City of Fayetteville Staff Review Form

SUBJECT: **A Resolution expressing the willingness of the City of Fayetteville to apply for and utilize Federal-aid funding for road & bridge improvement projects**

Bridge #19976(Routine)
Armstrong Avenue over Town Creek - Wash. Co.

Team Lead: Eric West Inspection Date: February 15, 2022

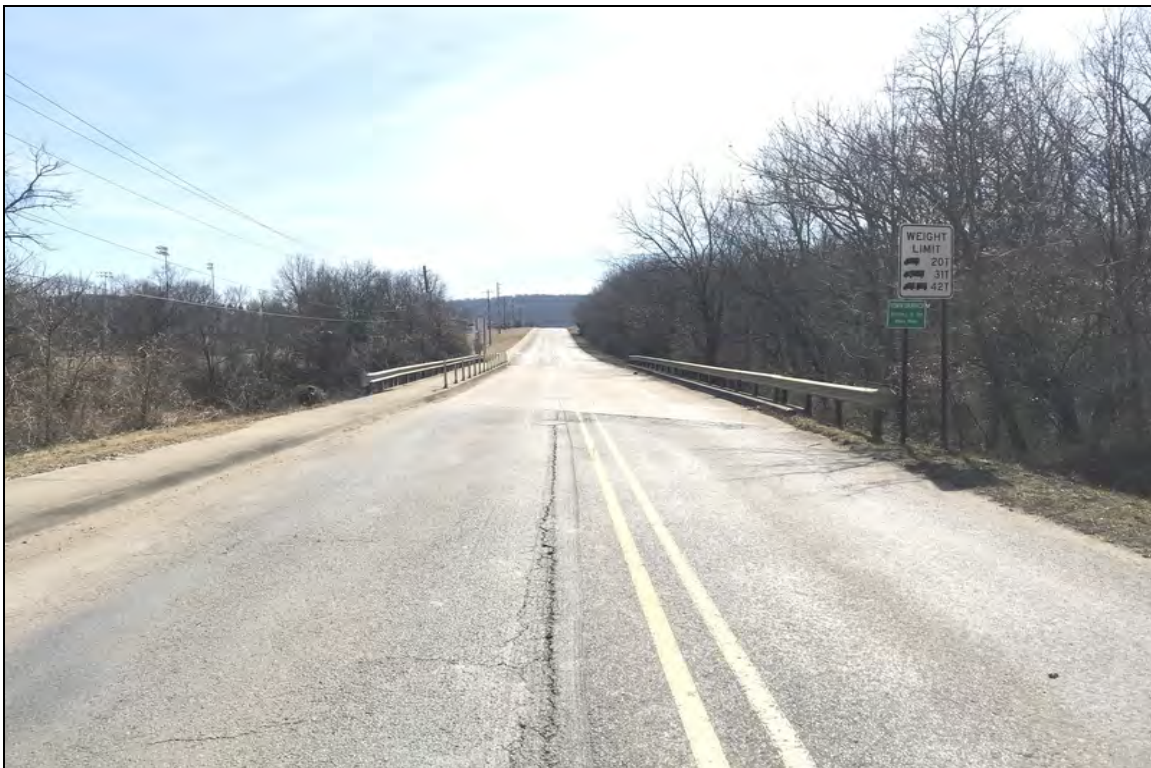
North approach load posting sign.

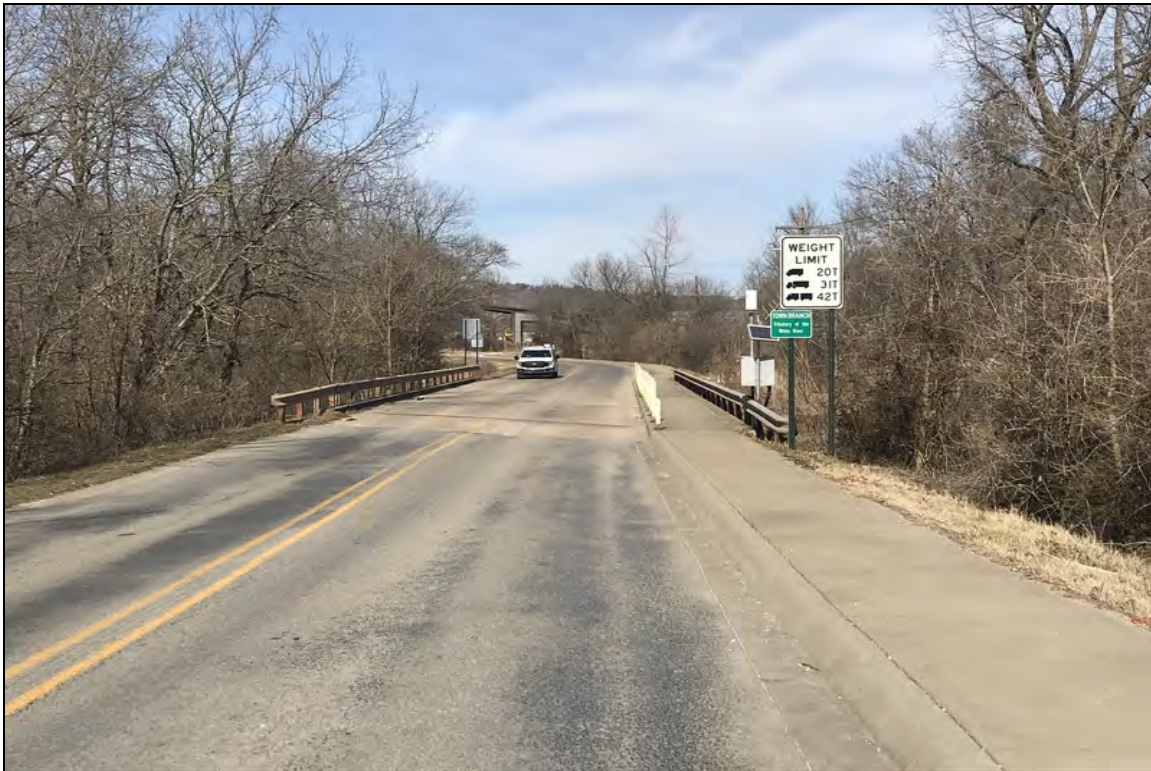
South approach load posting sign.

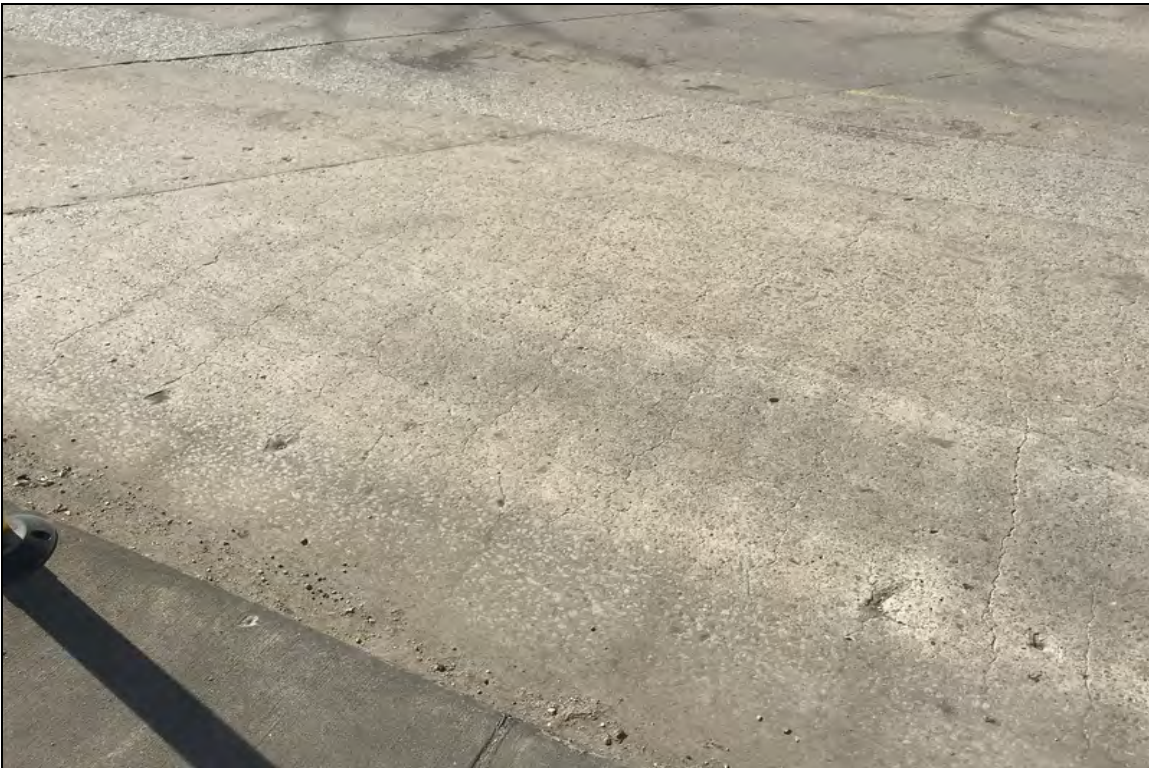
Span #2 sealable deck cracking.

Deck -
The driving surface of the deck has sealable cracking in all spans.

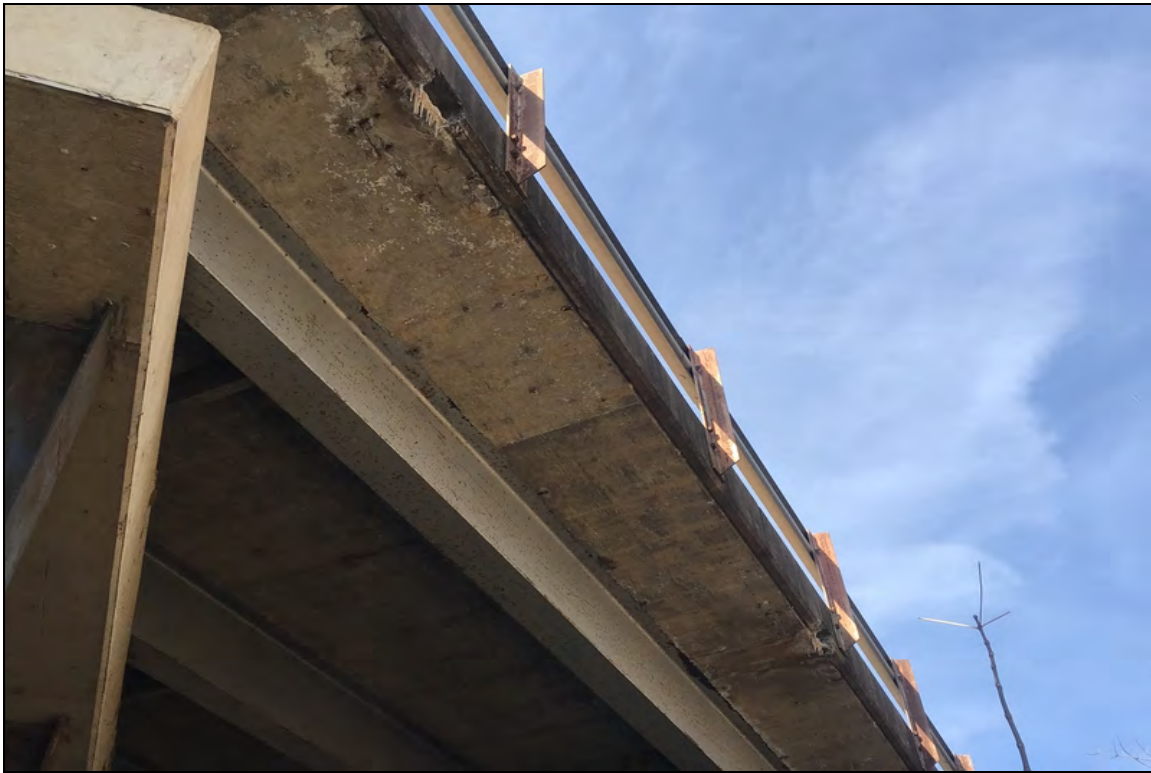
Span #1 Lt concrete delamination's, spalling and efflorescence buildup at the deck drains.

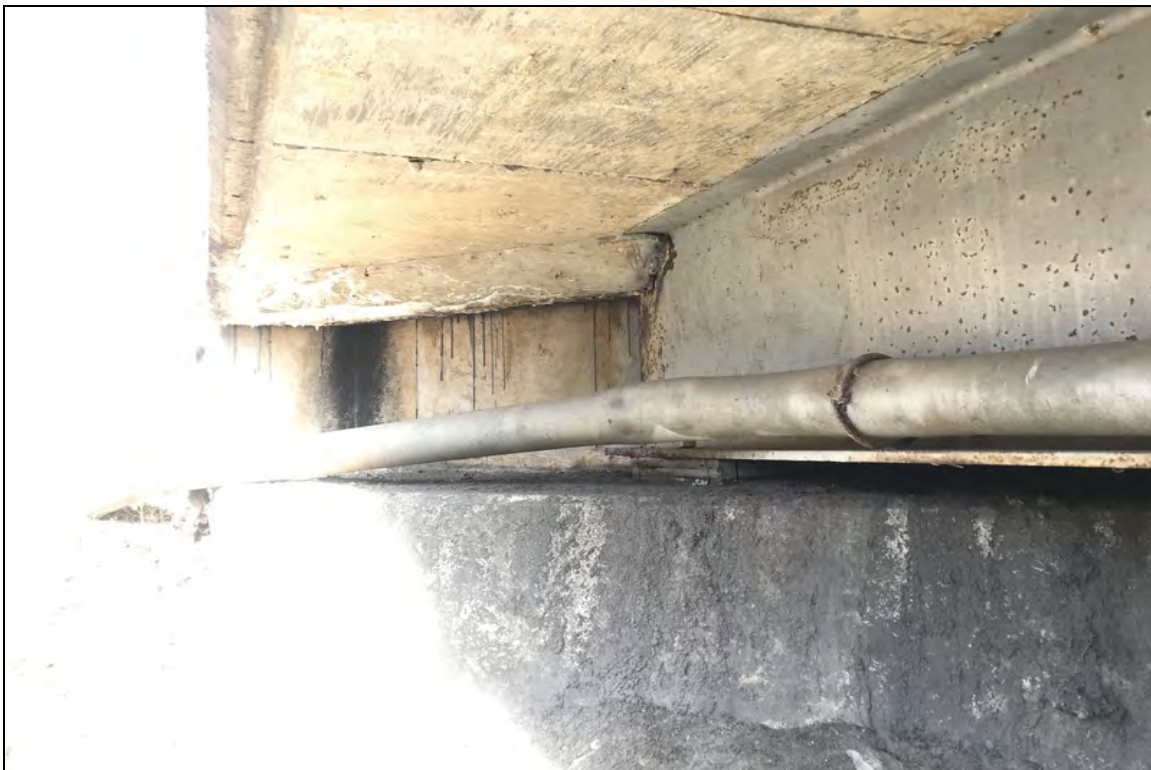
Span #1 Rt over abutment #1 with efflorescence buildup at the expansion dam.

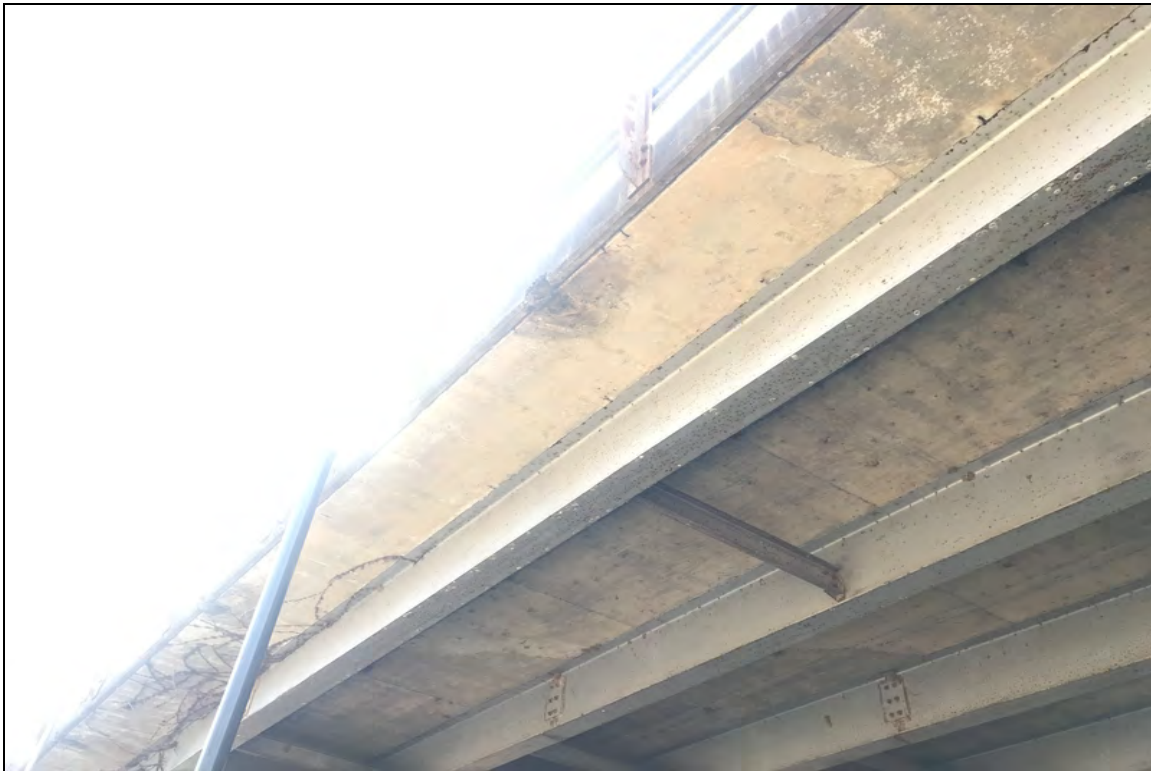
Span #2 Lt spalling with exposed reinforcing steel at the deck drains.

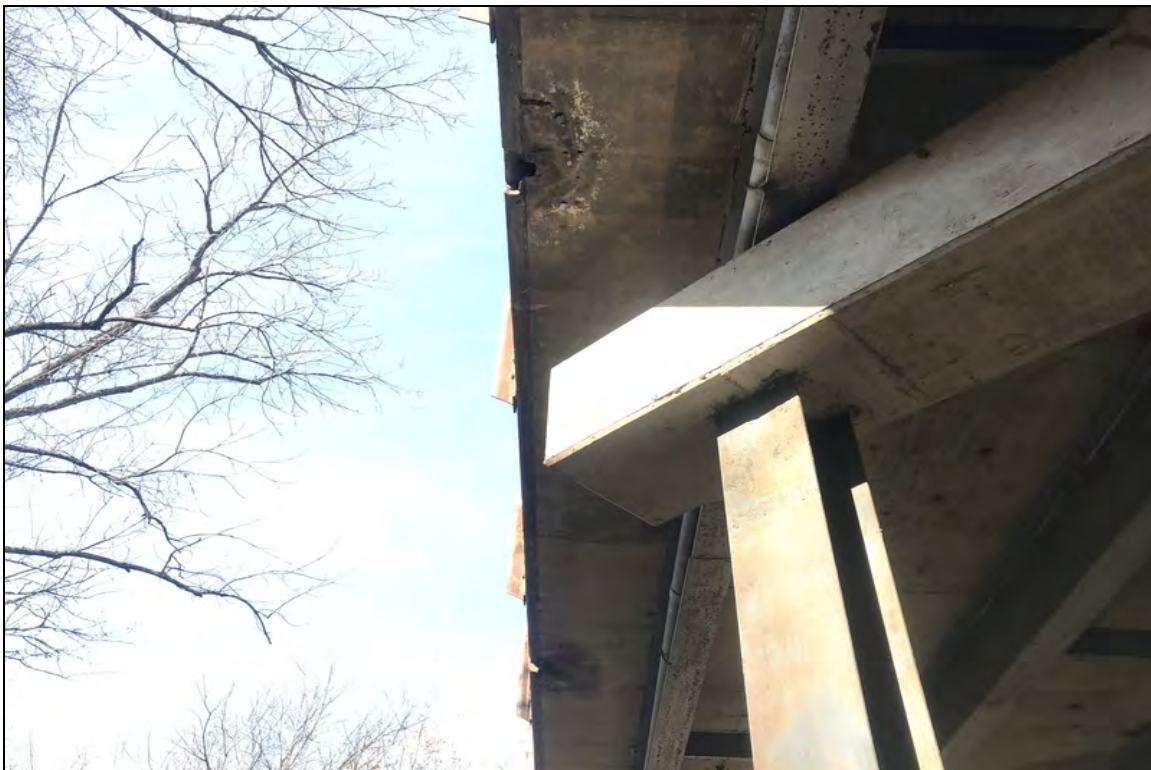
Span #2 & 3 concrete delamination's and spalling with exposed reinforcing steel in the edge of the deck overhang.

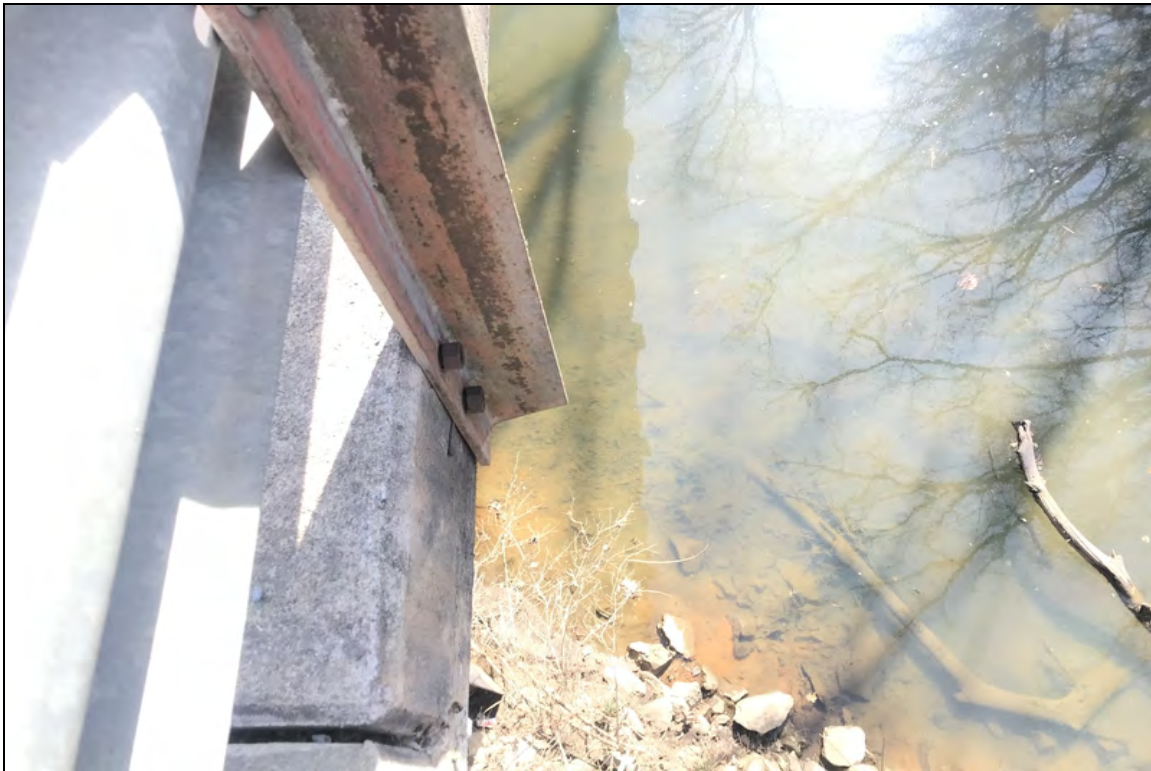
Rail posts are loosely bolted to the edge of the deck.

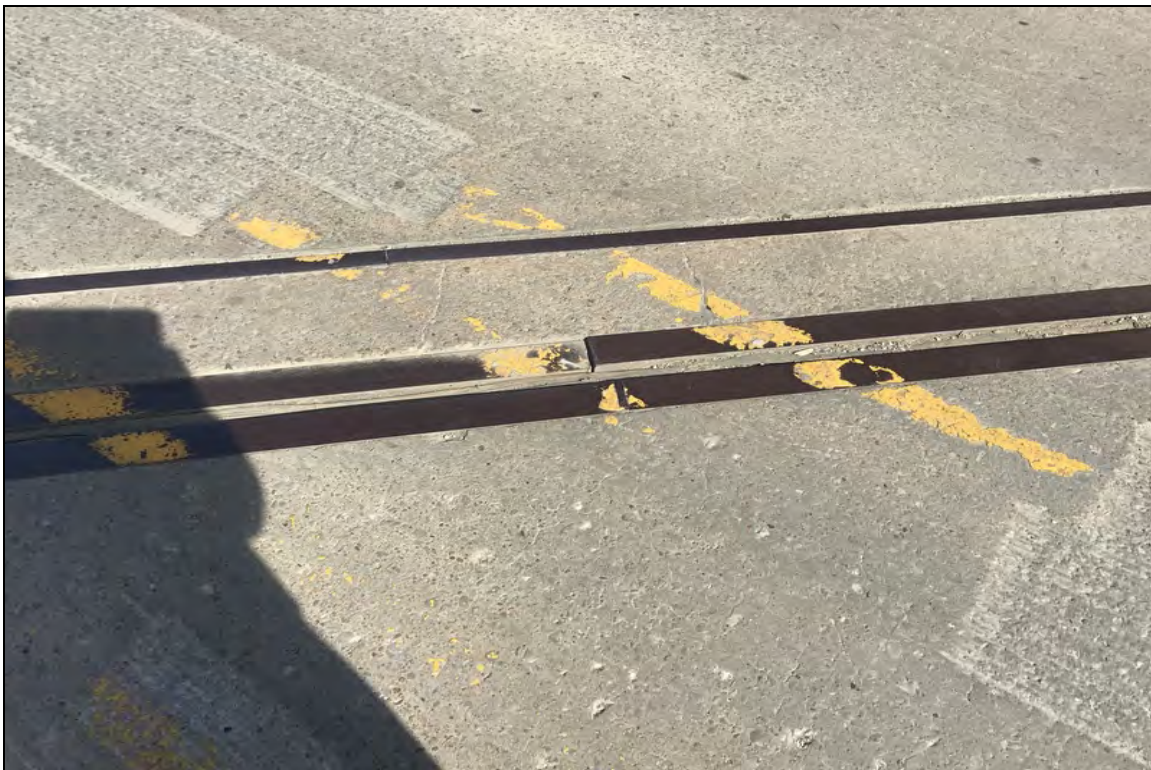
Abutment #1 expansion joint road irons not welded at the centerline.

The expansion joint assemblies at the North and South bridge ends -
The expansion joint anchorage is loose at both abutments. Both joints are noisy and have movement during live load impacts.
The joint seals are in place but leak water and debris on the abutments and the ends of the beams.

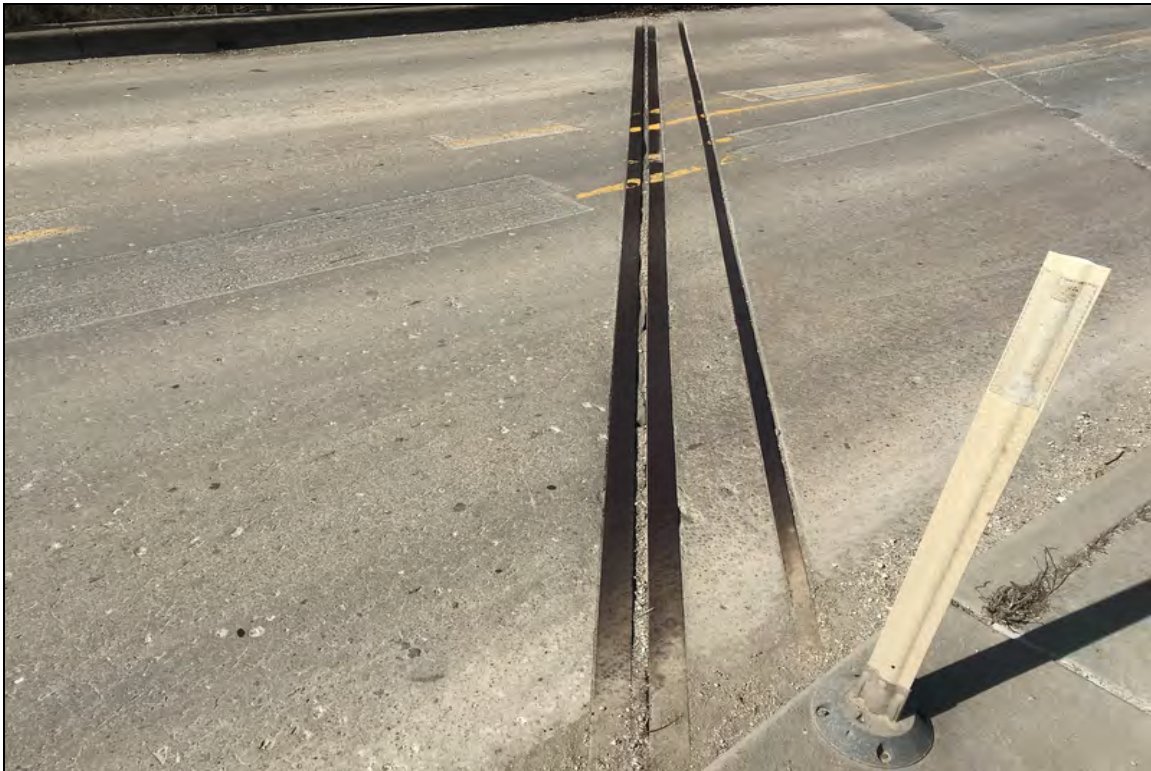
Abutment #1 failing joint seal.

- The expansion joint seals are in place at both abutments with areas of adhesion failure. Stains and debris accumulation on the abutments indicate that the seals leak.
- The metal expansion joint anchorage at both abutments is loose and fractured near the centerline of the structure and is noisy during live load impacts from traffic. The portion of the road iron in the right lane of the South approach roadway between abutment #2 and the South approach slab is missing.

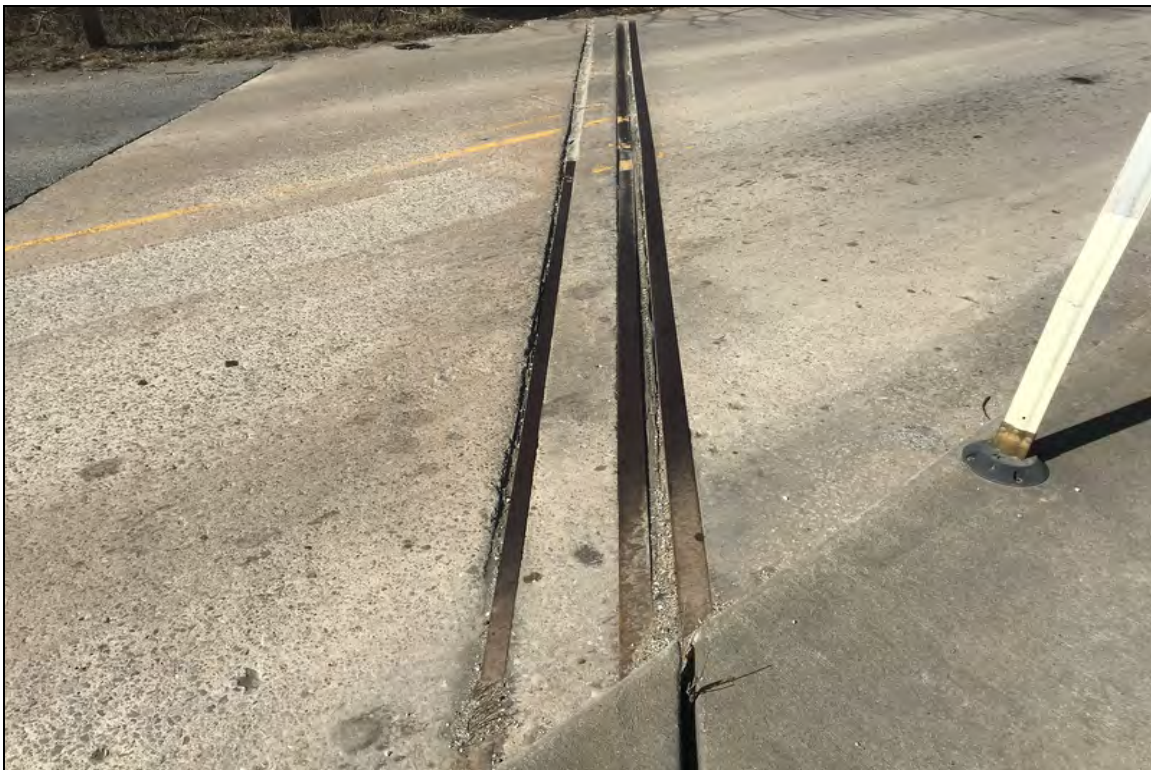
Abutment #2 failing joint seal.

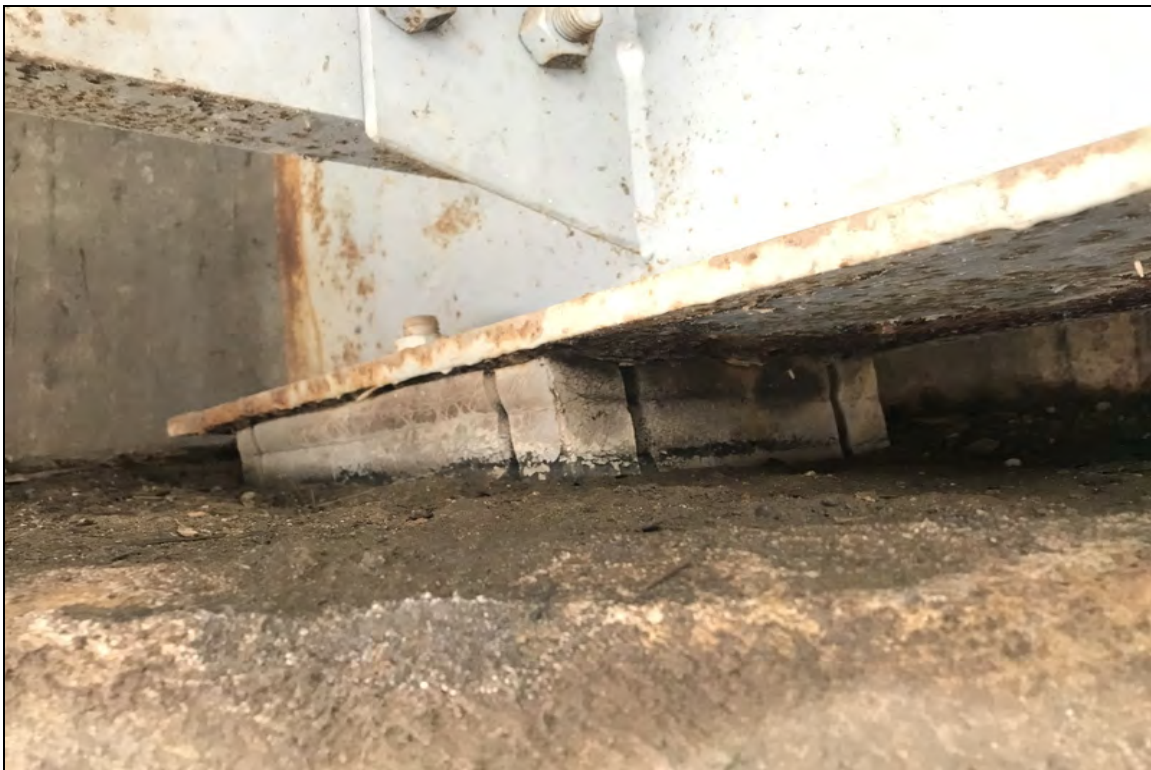
Abutment #1 beam #3 with active corrosion and layers of flaking rust forming between the bearing and beam.

- Active corrosion is forming in the ends of the beams over the abutments where the expansion joints leak water on the superstructure. The most noteworthy area is at abutment #2, Beam # 3. The bottom flange is reduced to 5/16" adjacent to the bearing at this inspection with no apparent repairs since the last inspection with an increase of 1/8" since the last inspection. The bearing shim plates over the abutment #2 have heavy corrosion, section loss and pack rust.
- The beams over the abutments have active corrosion with layers of flaking rust forming between the beams and the bearings.
- The exterior beams have corrosion to top flanges where deck drains discharge water.

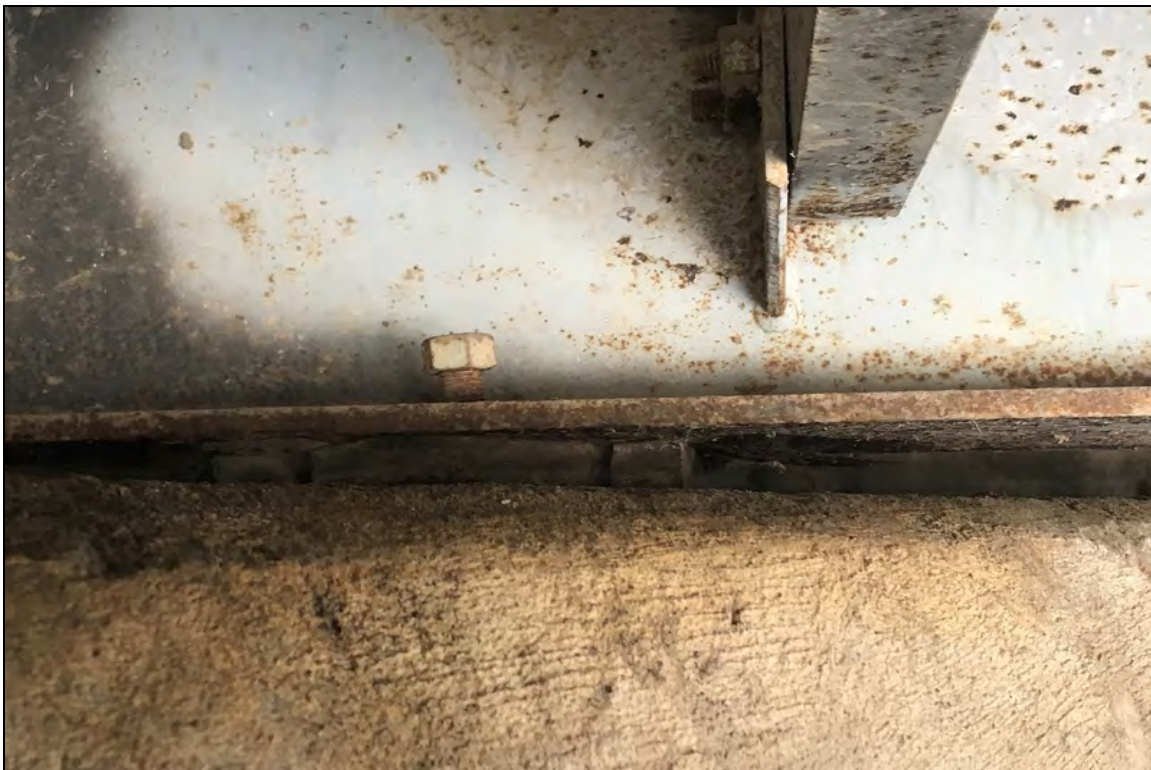
Abutment #2 beam #4 active corrosion with layers of flaking rust between the bearings and beam.

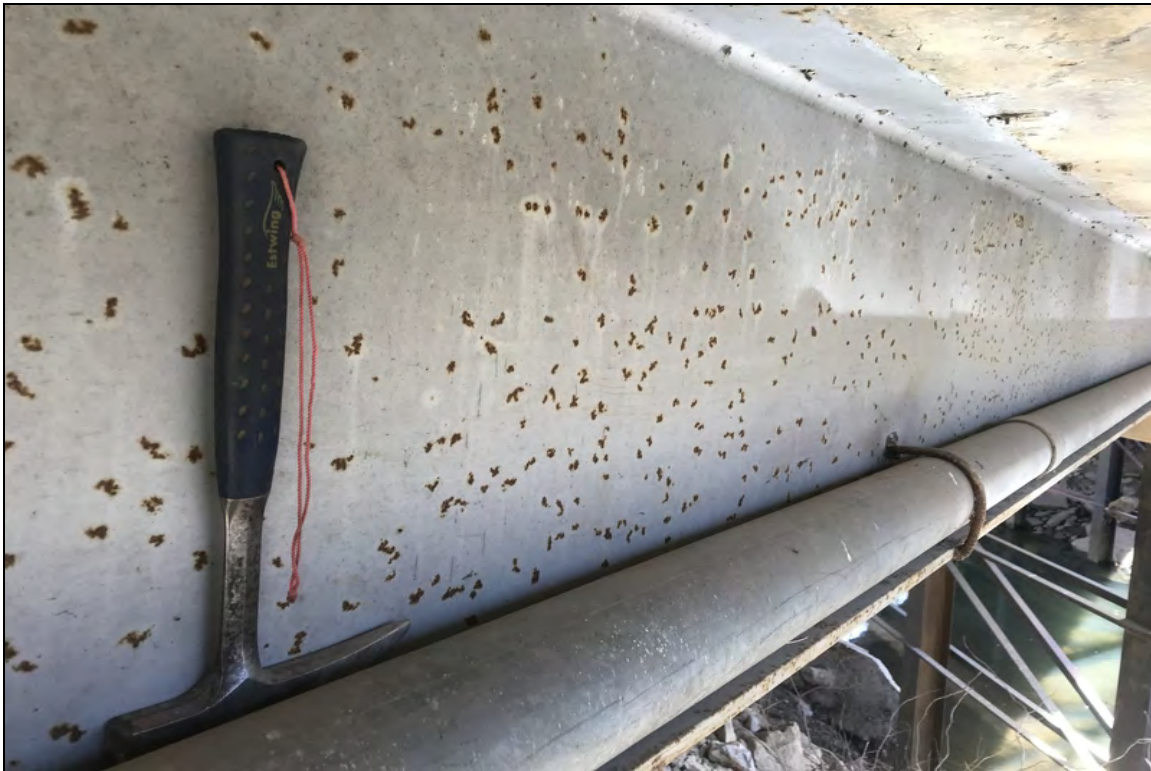
Typical failing paint system.

- Freckled rust typical in all spans with active corrosion and flaking rust at the abutments.

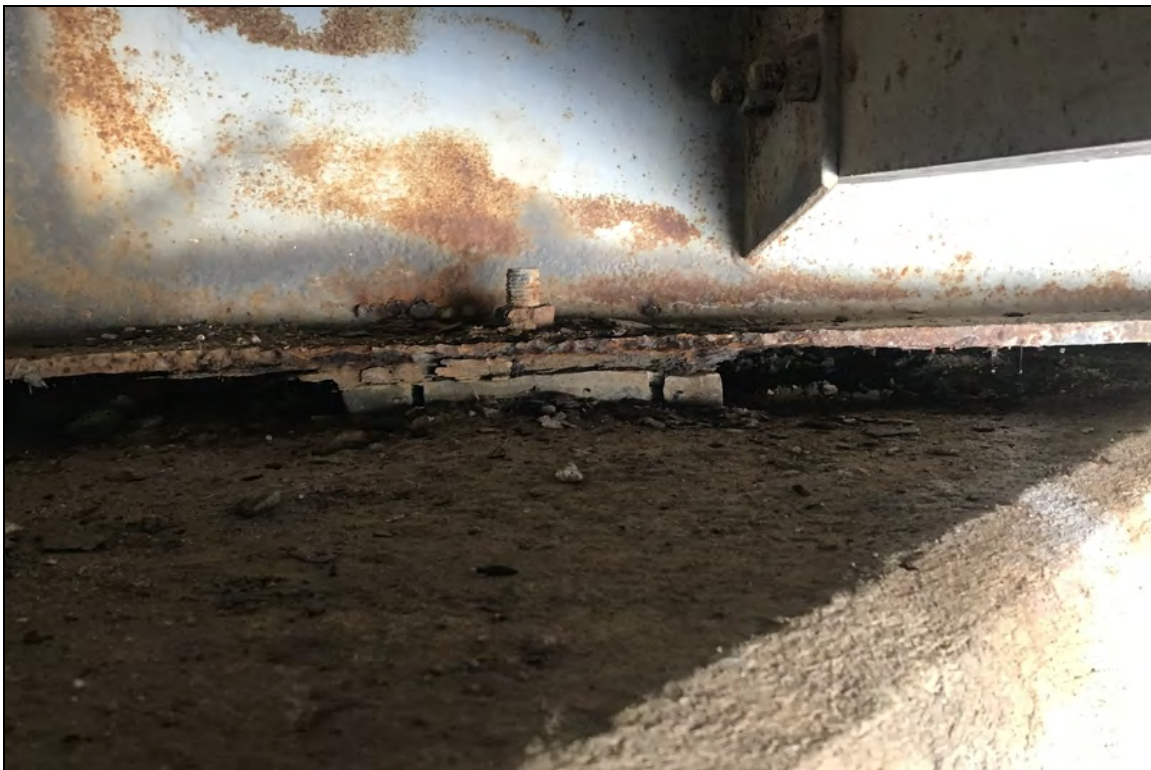
Abutment #2 beam #3 active corrosion with layers of flaking rust and 5/16" remaining section adjacent to the bearing.

There is active corrosion forming in the ends of the beams over the abutments where the expansion joints leak water on the superstructure. The most noteworthy example is at Bent # 4, Beam # 3. The bottom flange is reduced to 5/16" adjacent to the bearing at this inspection. The sole plates have heavy deterioration, section loss and pack rust. The majority of the superstructure has freckled rust showing through the paint system.

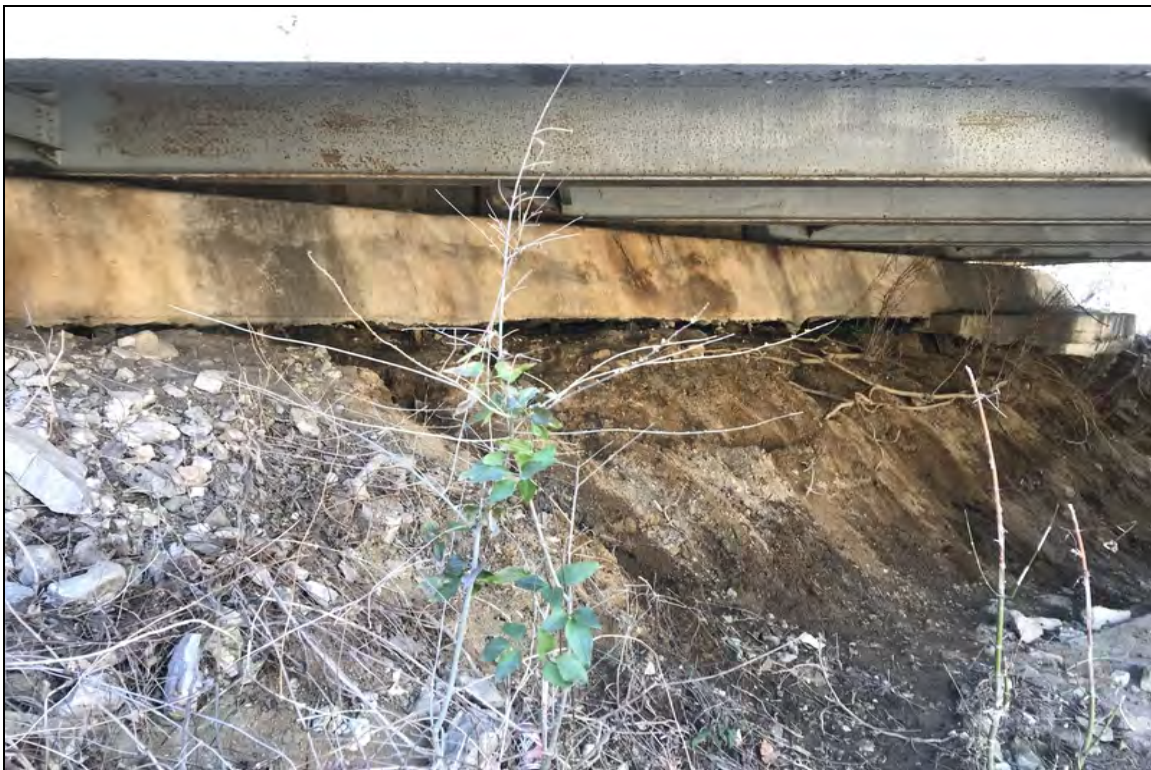
Abutment #2 erosion under the abutment.

The channel embankment adjacent to the north and south abutments -
There is significant embankment erosion adjacent to both abutments with earth settlement under both abutment caps. Earth settlement has exposed the piling. Exposed piling have active corrosion with up to 1/8" section loss during this inspection.
Concrete collars placed adjacent to the abutments in the past as an erosion countermeasure are undermined.

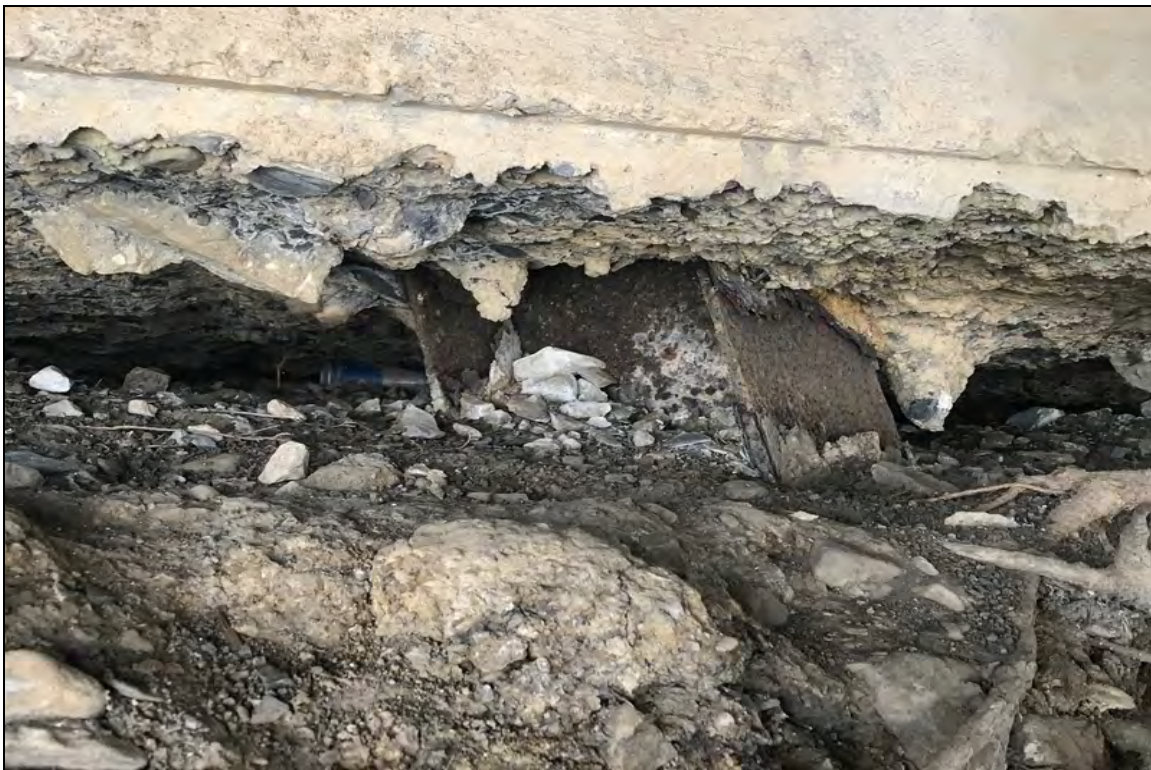
Abutment #2 steel pile with layers of flaking rust and section loss.

- Both abutments have earth settlement / erosion that expose some of the steel piling. Exposed steel piling at the abutments have active corrosion with flaking rust and section loss up to 1/8" at this inspection. The exposed piling are 10" x 10" with exposed areas that are reduced to 5/16" at the flanges.
- Abutment #2 has up to 4' of earth settlement under the abutment cap.
- Concrete collars placed adjacent to the abutments in the past by maintenance forces are completely undermined and no longer functioning as intended.

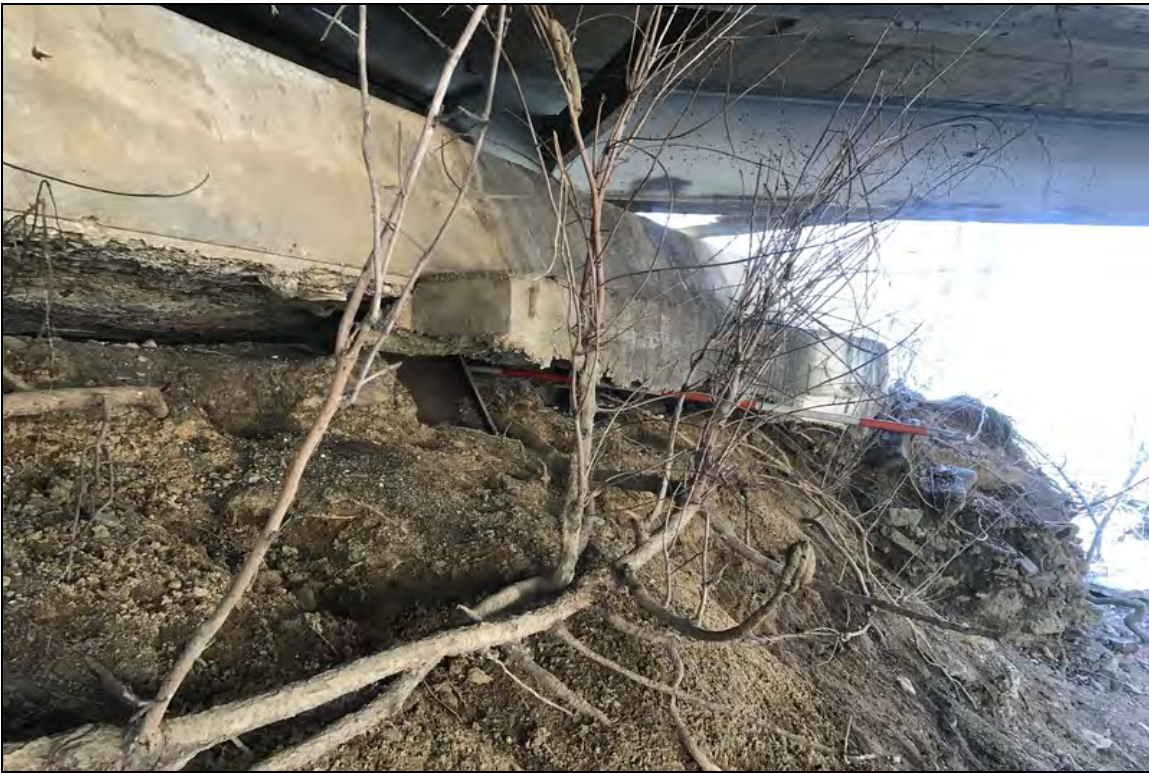
Abutment #2 with full depth erosion under the abutment cap.

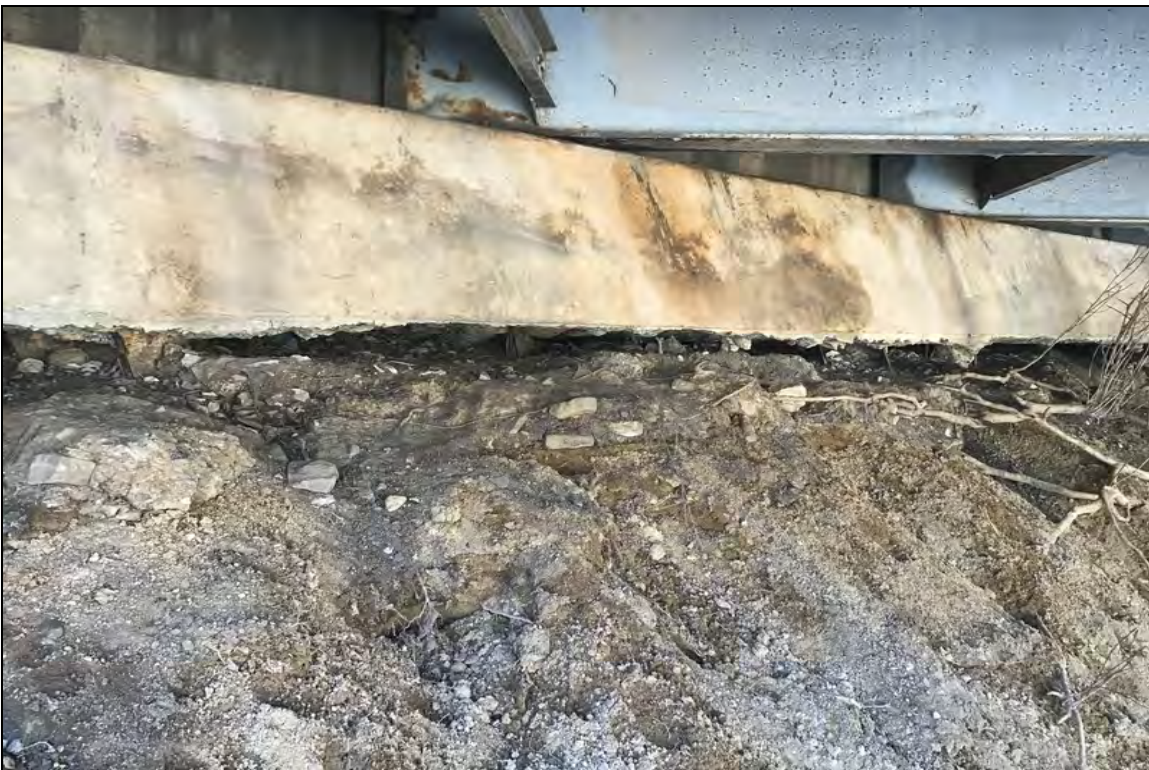
Abutment #2 exposed steel piling.

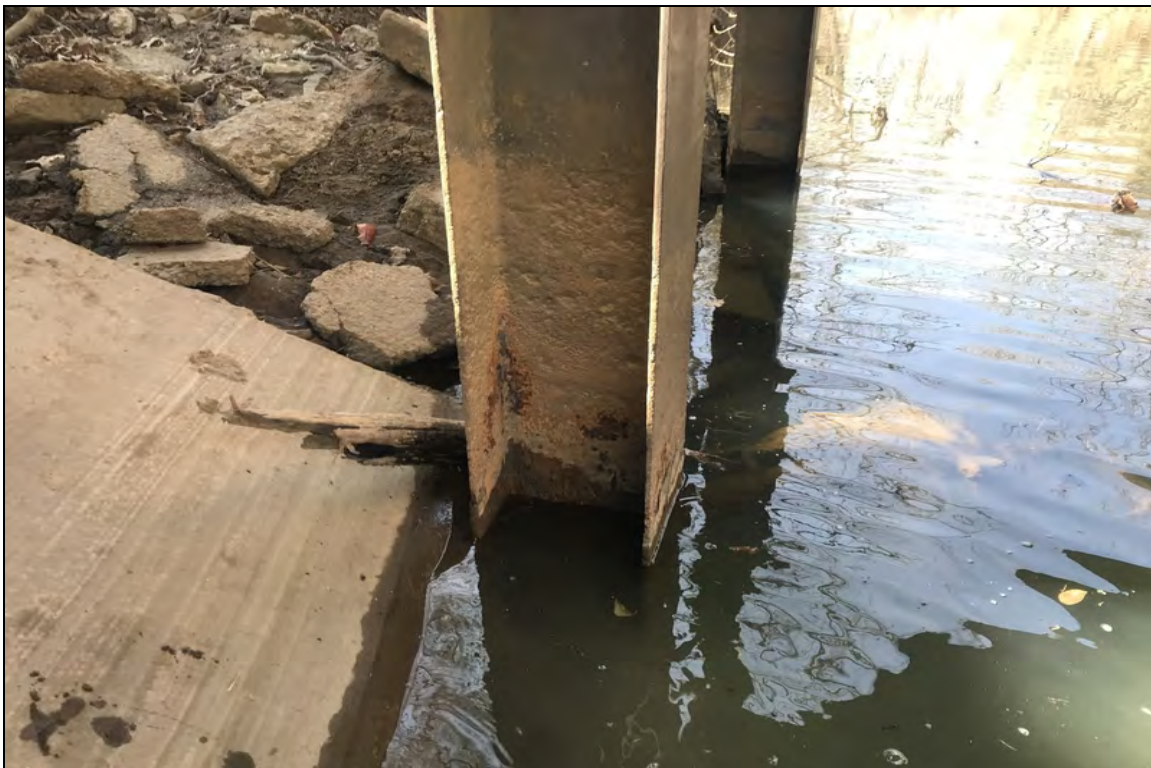
Bent #3 pile #4 active corrosion with layers of flaking rust and measurable section loss at the base of the pile.

- Bent #3 pile #1 & 2 have rip rap cover and do not appear to have measurable section loss where exposed at the base.
- Bent #3 pile #3 has approximately 1/8" section loss to the flanges and approximately 3/16" to the base of the web at the water elevation.
- Bent #3 pile #4 has approximately 1/8" section loss to the flanges and approximately 5/16" to the base of the web at the water elevation.
- Bent #3 pile #5 has areas with 5/16" section loss to the flanges and approximately 5/16" to the base of the web.

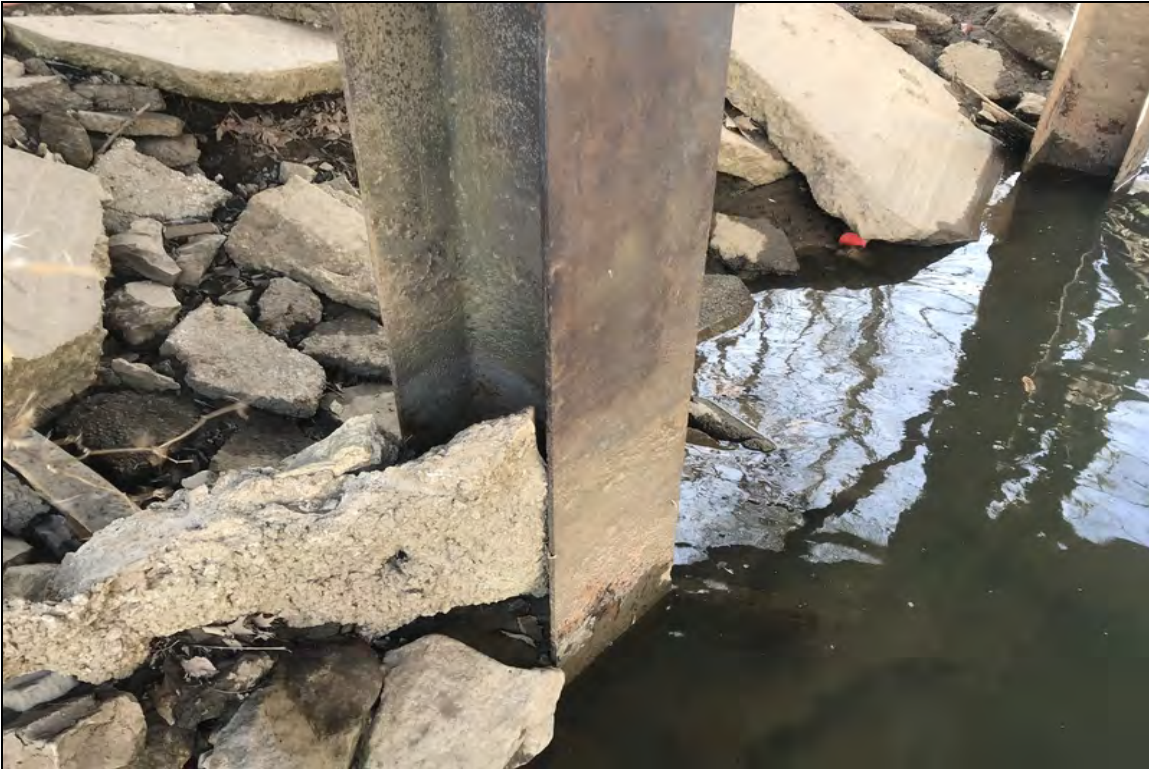
Bent #3 pile #3 with active corrosion and layers of flaking rust with measurable section loss at the base of the pile.

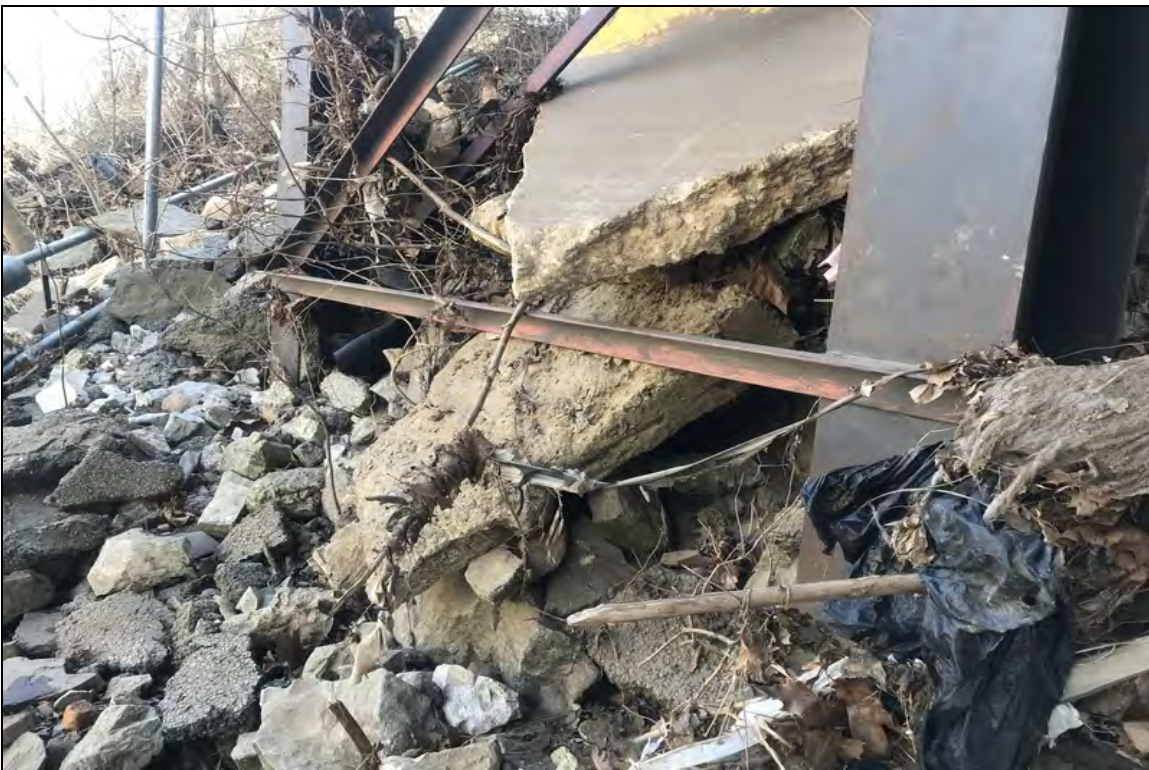
Bent #3 pile #1 & 2 have no apparent section loss at the base of the piling.

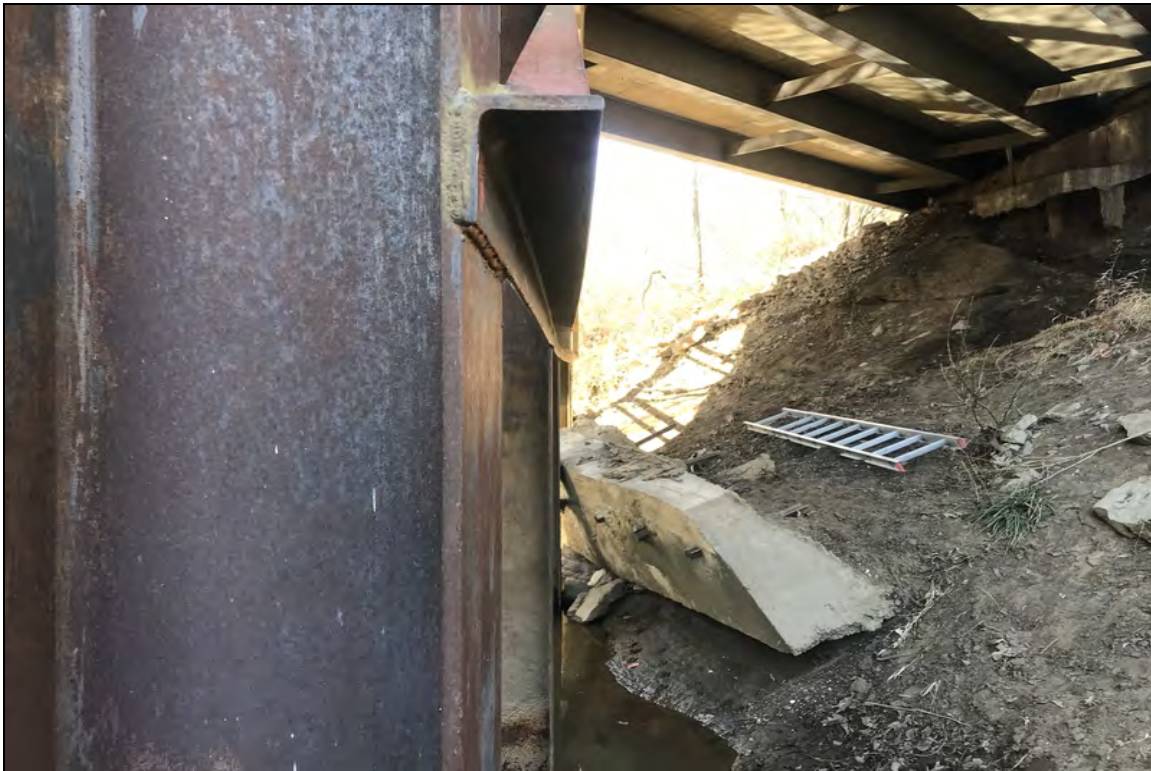
Bent #2 minor misalignment of the steel piling where concrete fell against the bent.

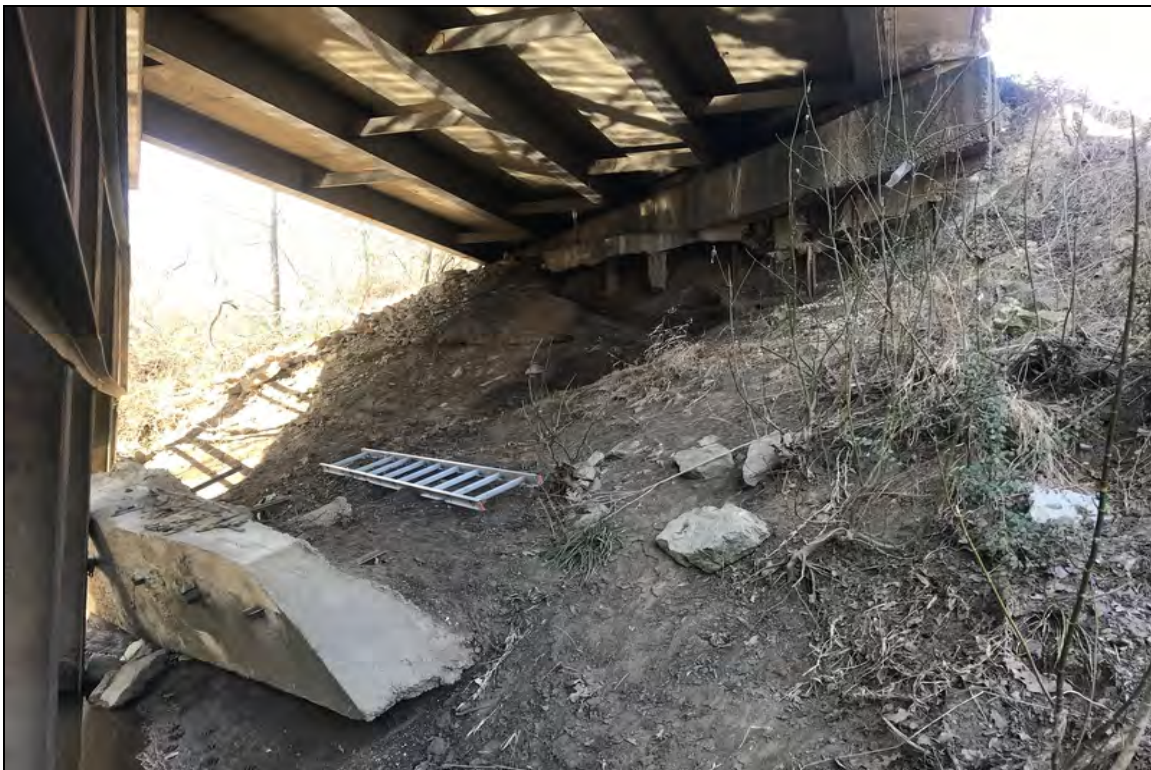
Abutment #1 fractured concrete repair collar.
