City of Fayetteville Staff Review Form

SUBJECT: **A Resolution expressing the willingness of the City of Fayetteville to apply for and utilize Federal-aid funding for road & bridge improvement projects**

Bridge #19976(Routine)
Armstrong Avenue over Town Creek - Wash. Co.

Team Lead: Eric West Inspection Date: February 15, 2022

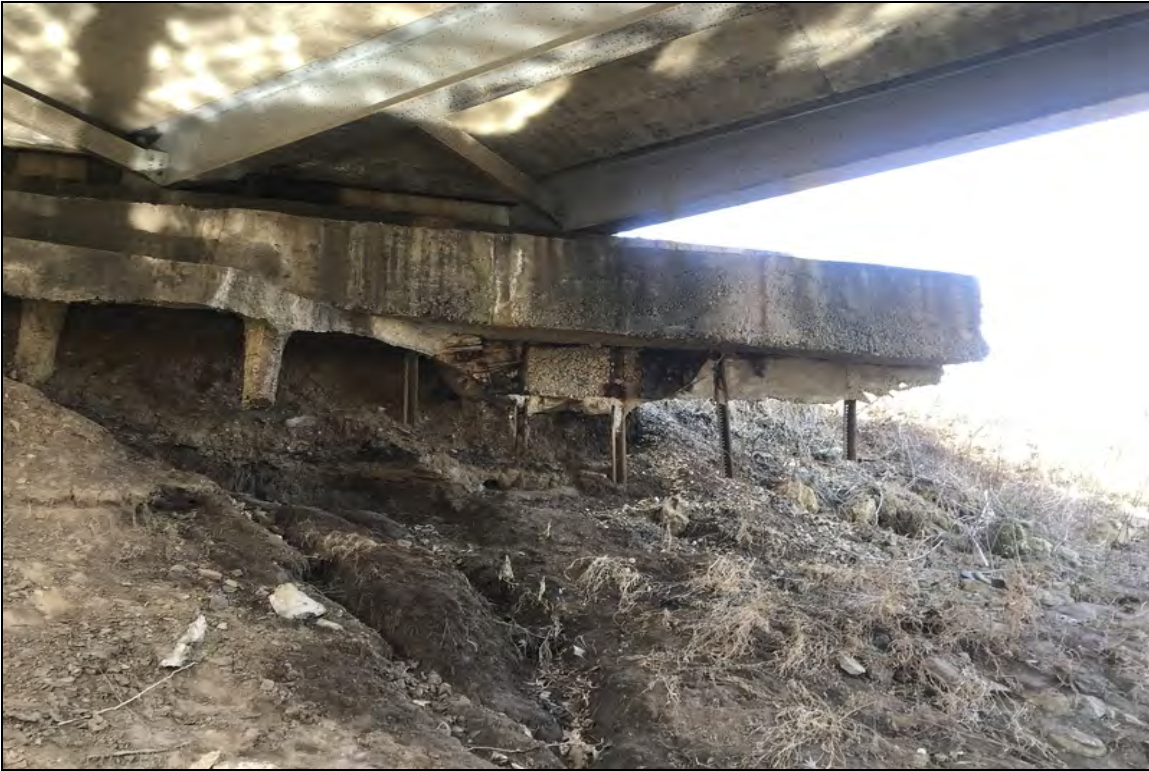
Abutment #1 with a fractured section of the repair.

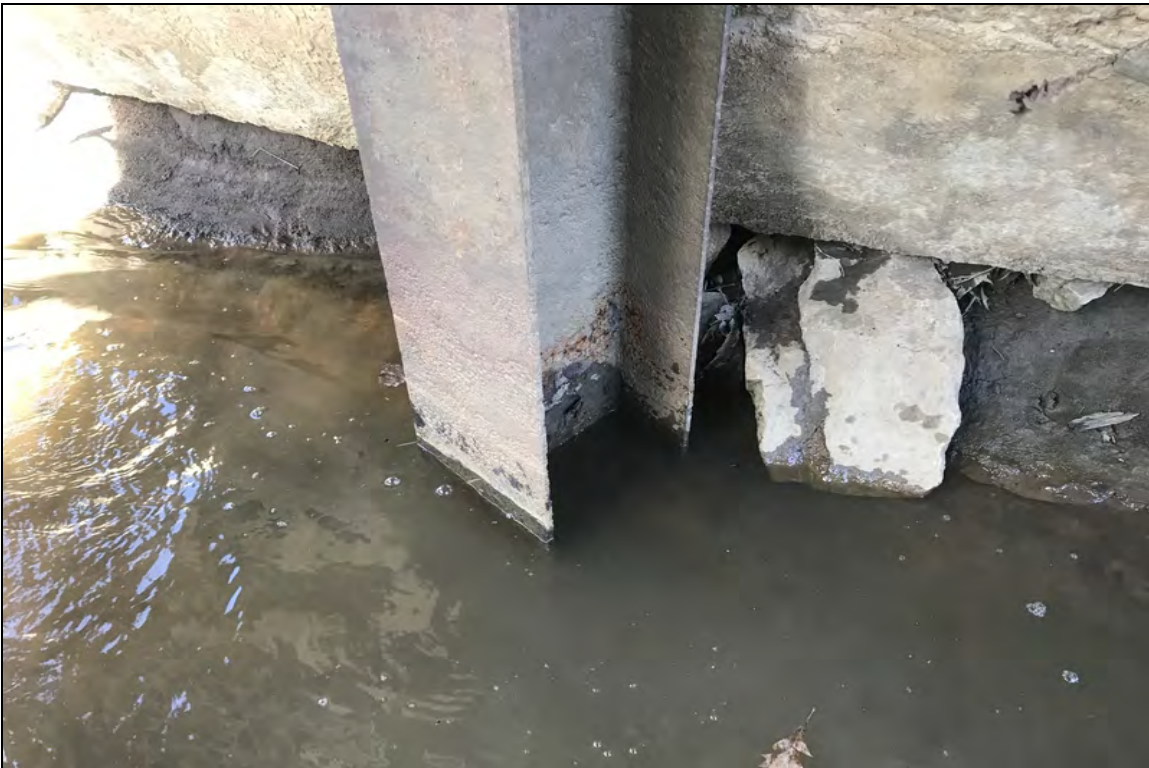
Bent #2 pile #3 active corrosion with layers of flaking rust and measurable section loss.

- Bent #2 pile #1 has up to 1/4" section loss and the edges of the flanges reduced to knife edge in locations. The pile has been reduced from 12 1/16" to 11 1/2" at the water elevation. Pile has approximately 3/16" remaining section at the water elevation.
- Bent #2 pile #2 has up to 3/8" section loss the the flanges in areas. The web has up to 5/16" section loss on one side of the web and up to 3/16" in the same area in the corresponding area of the opposite side. No hole were found. The pile width has been reduced by approximately a 1/4" due to corrosion.
- Bent #2 pile #3, 4 & 5 have approximately 1/8" section loss to the base of the web and the flanges at the water elevation.

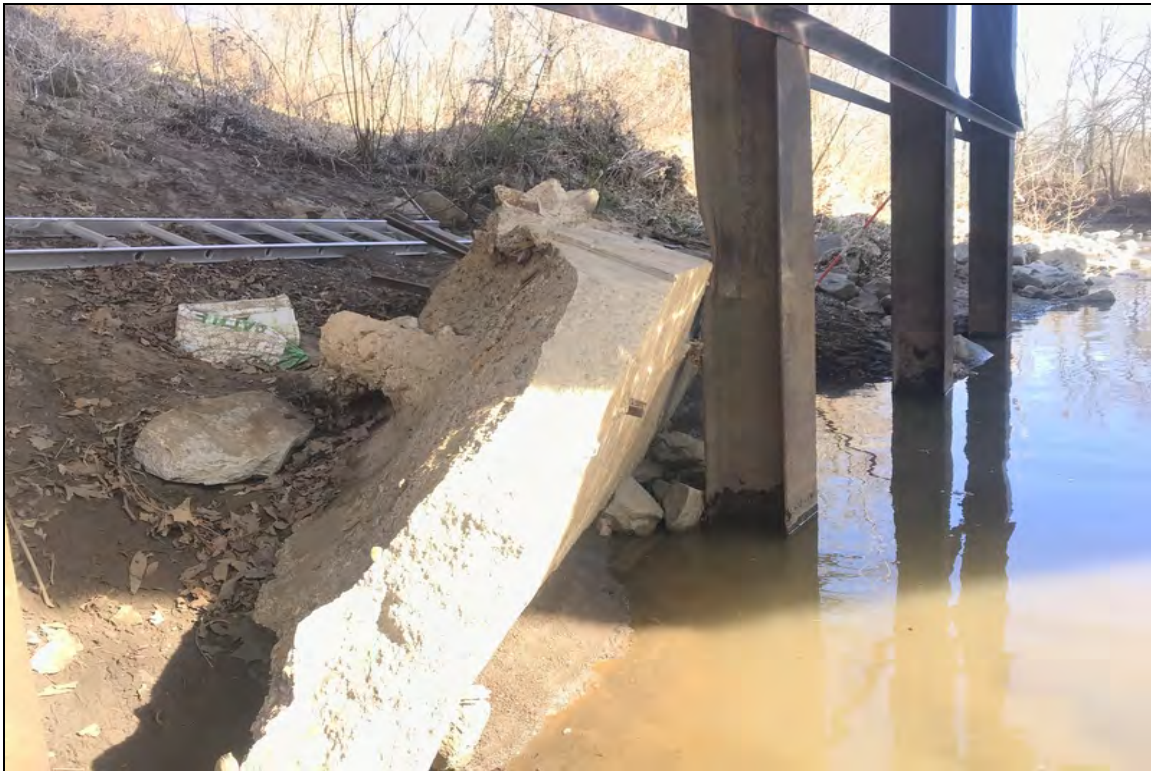
Bent #2 pile #3 out of plane bending.

Bent #2 pile #3 has approximately 3" of out of plane bending from a portion of concrete that has fracture from the repair at Abutment #1 and fell against the pile.

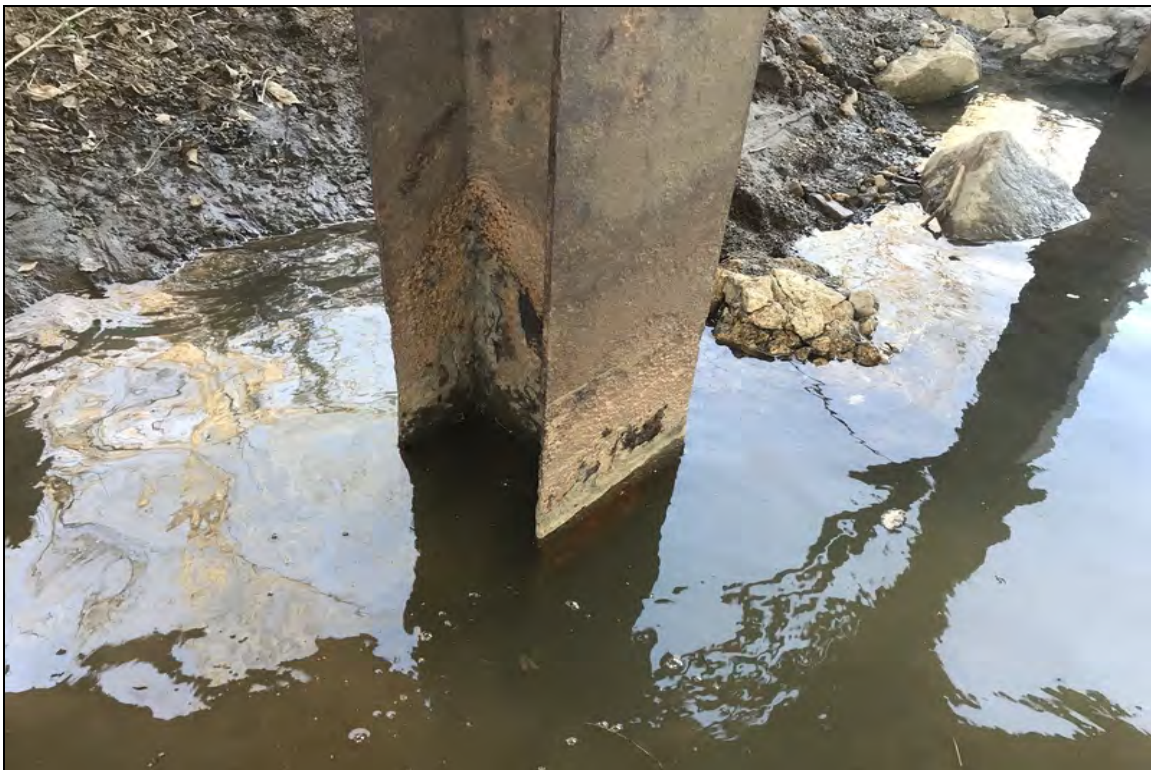
Bent #2 pile #2 active corrosion with layers of flaking rust with measurable section loss.

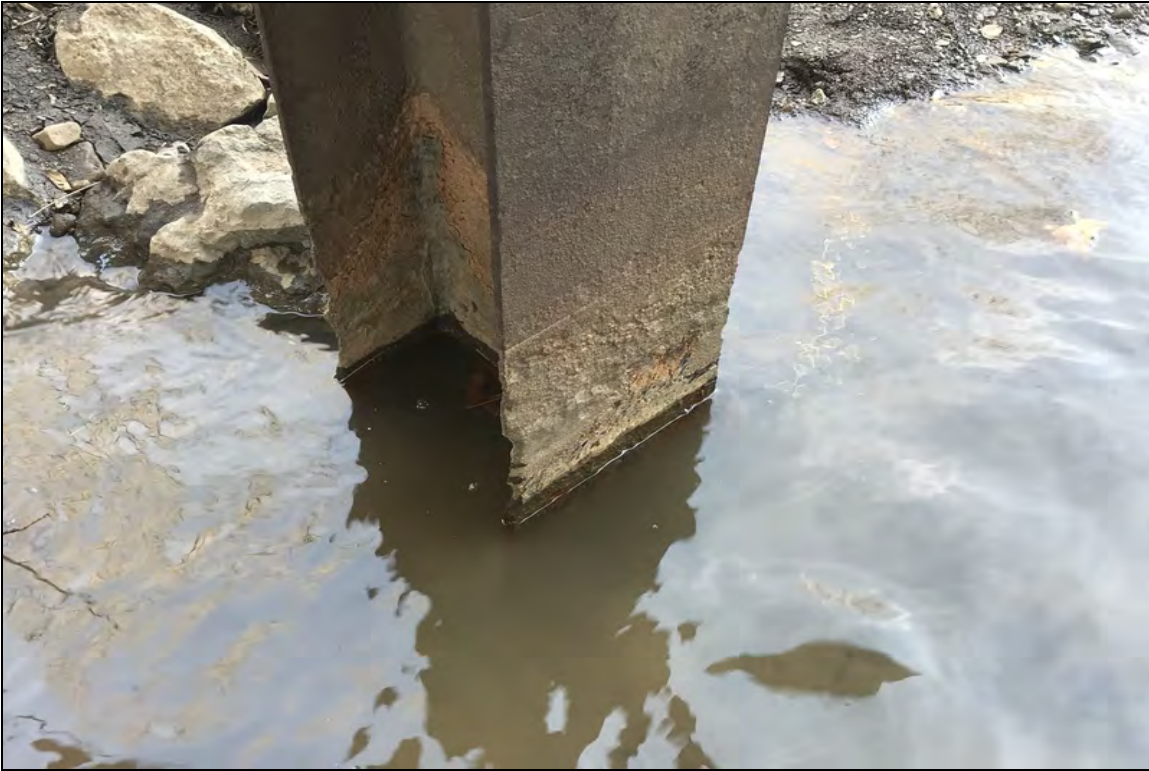
Bent #2 pile #1 with active corrosion and layers of flaking rust with measurable section loss.

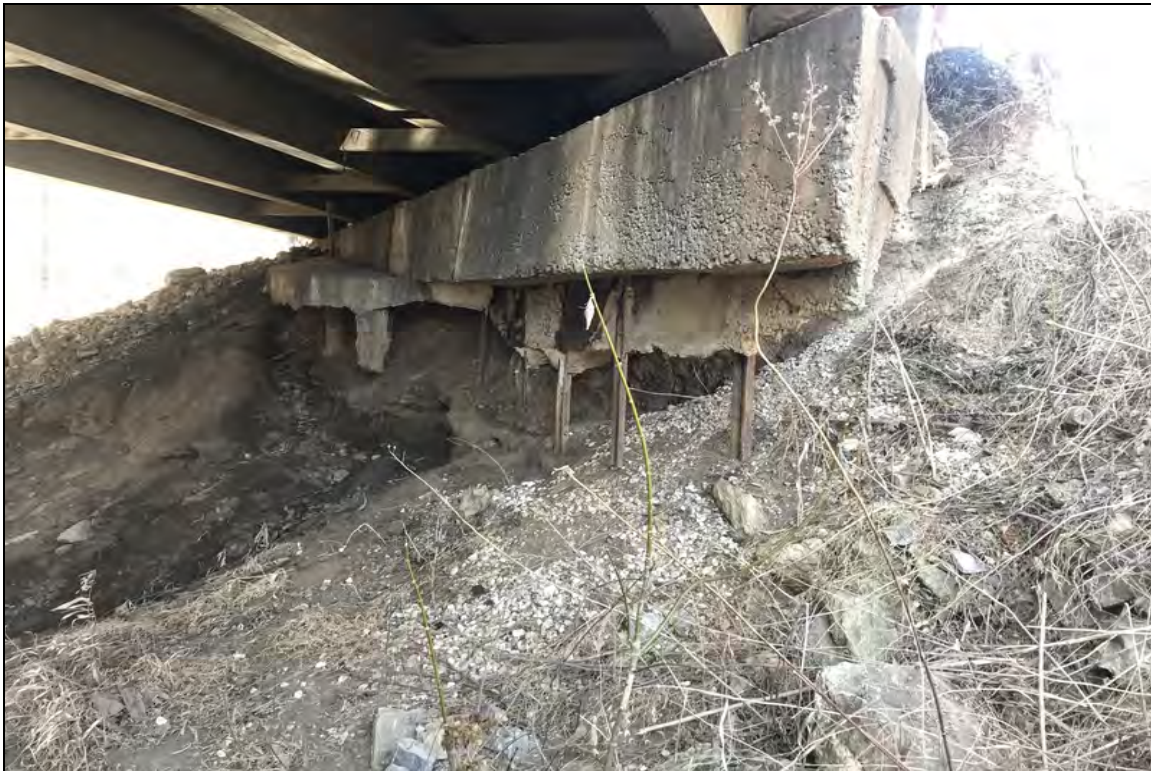
Abutment #1 erosion.

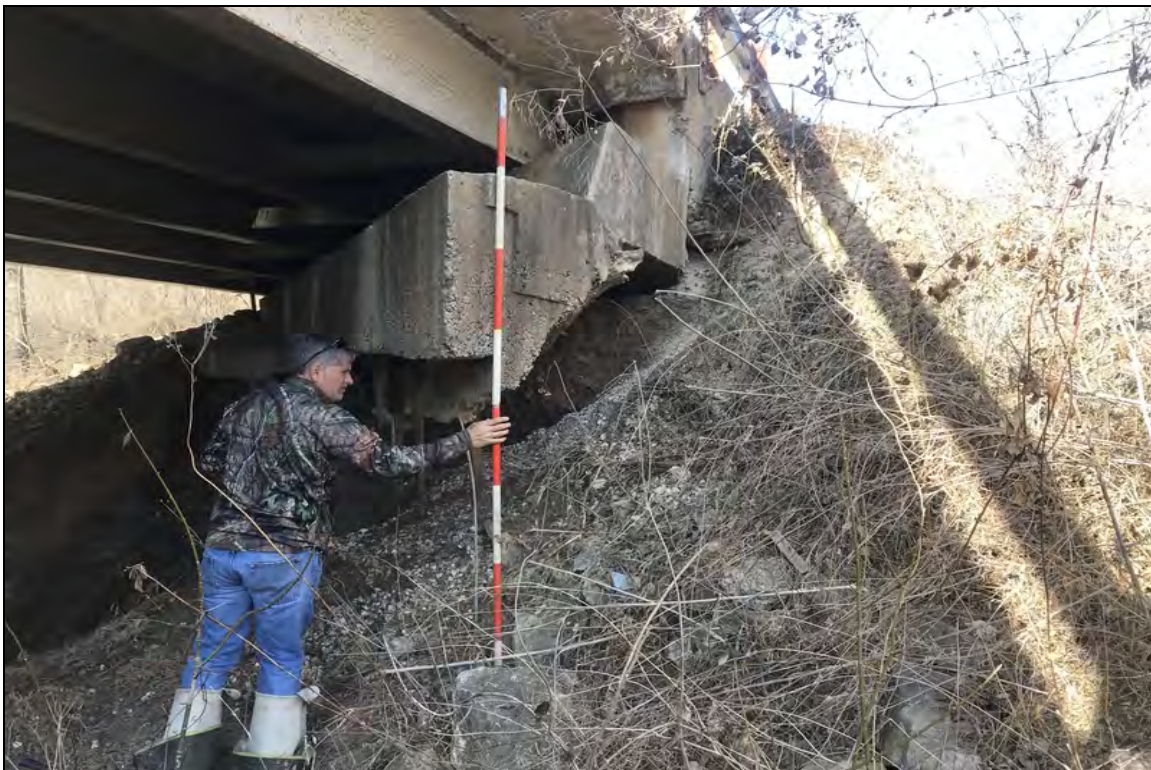
Abutment #1 Lt erosion under the edge of the abutment.

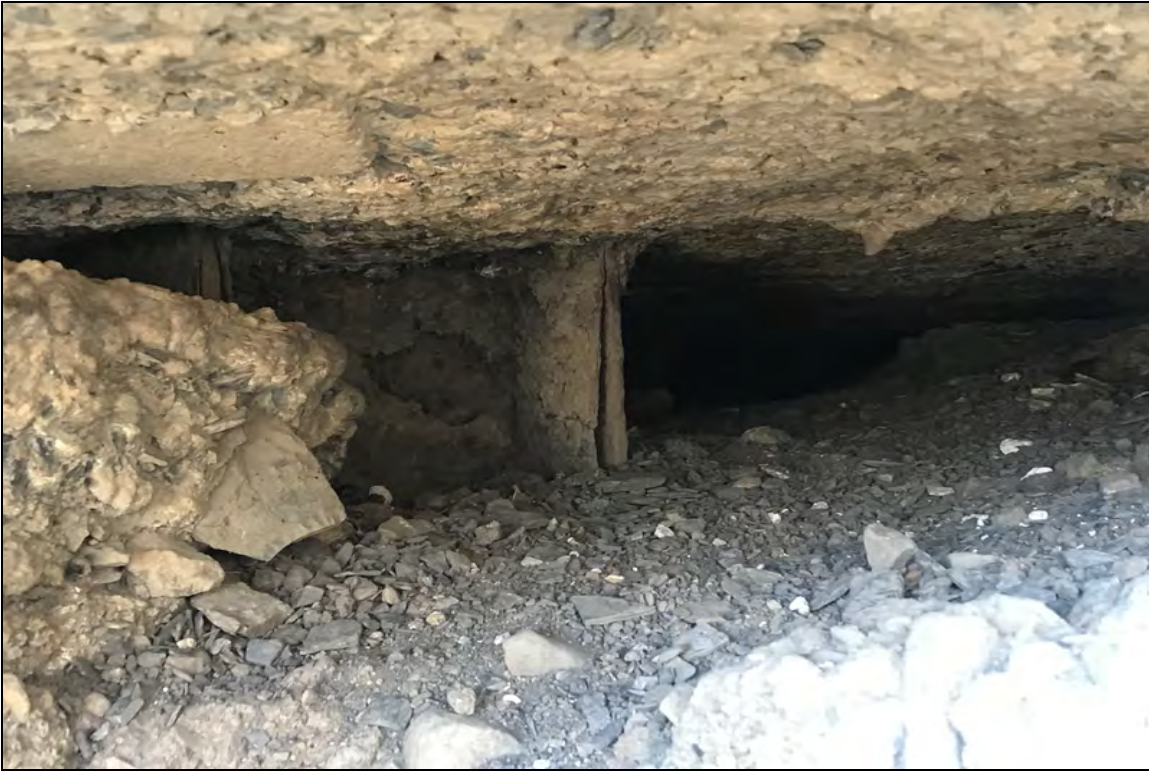
Abutment #1 pile #1 exposed with layers of flaking rust.

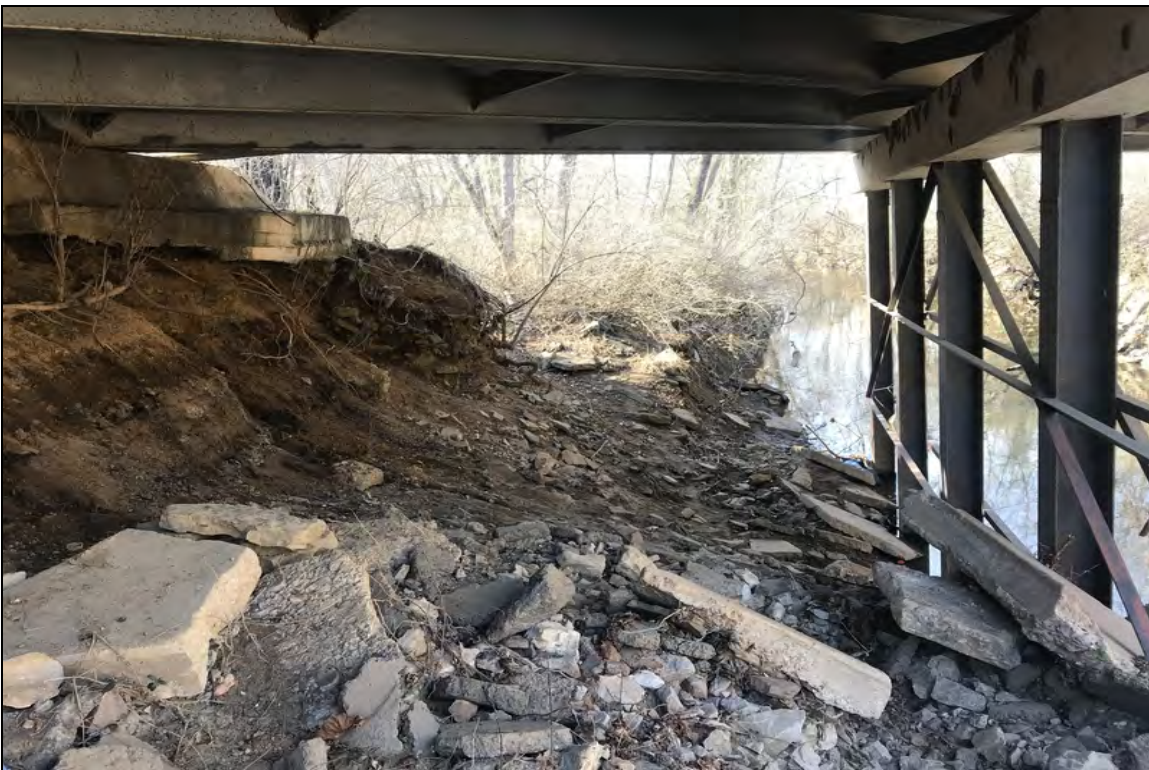
Span #3 erosion.

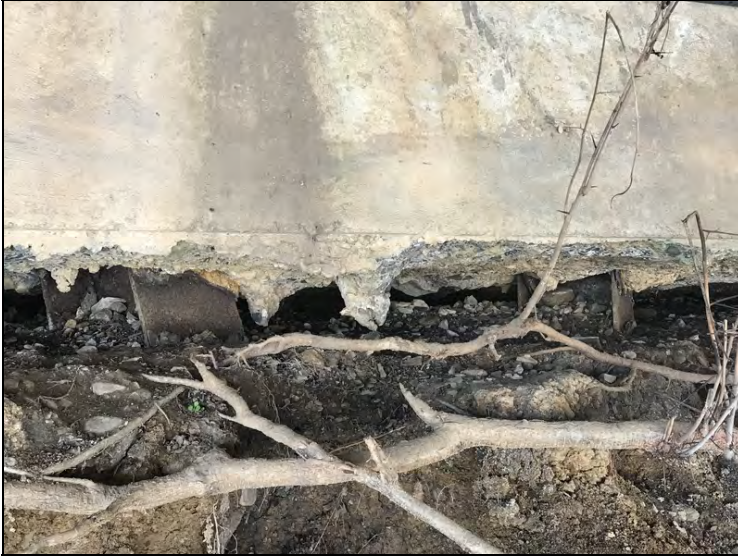
There is significant embankment erosion adjacent to both abutments with earth settlement under both abutment caps.
Earth settlement has exposed the piling. Exposed piling have active corrosion with up to 1/8" section loss during this inspection.
Concrete collars placed adjacent to the abutments in the past as an erosion countermeasure are undermined.

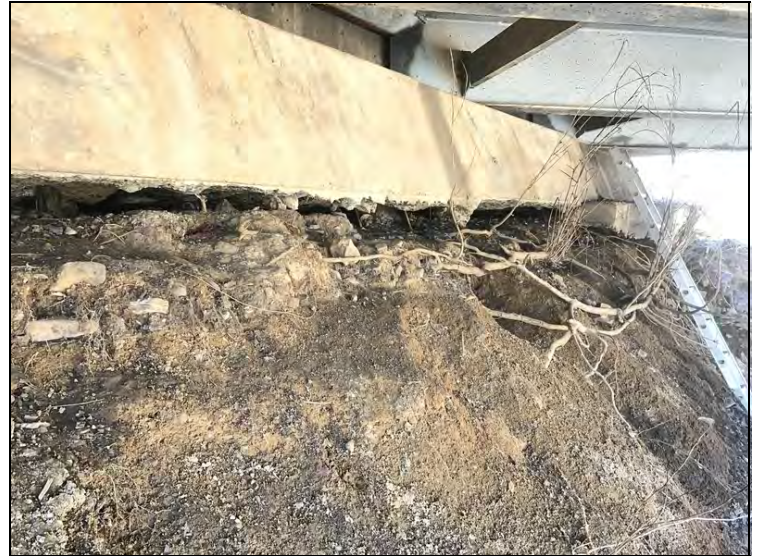
There is significant embankment erosion adjacent to both abutments with earth settlement under both abutment caps.
Earth settlement has exposed the piling. Exposed piling have active corrosion with up to 1/8" section loss during this inspection.
Concrete collars placed adjacent to the abutments in the past as an erosion countermeasure are undermined.

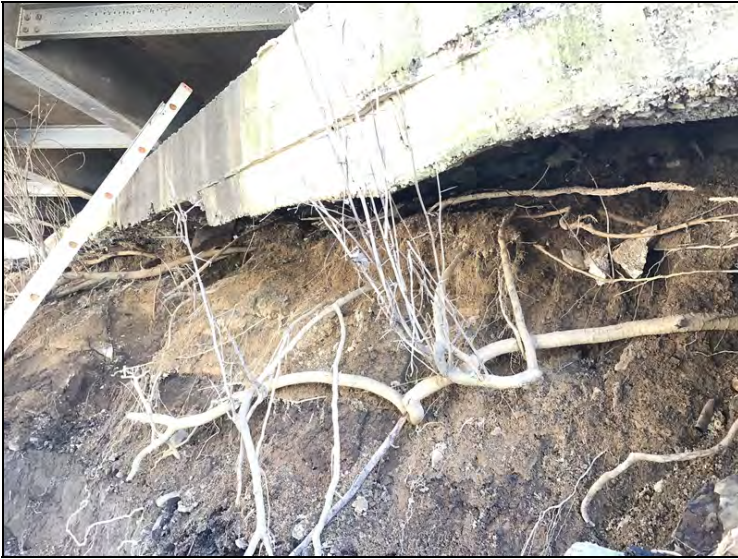
There is significant embankment erosion adjacent to both abutments with earth settlement under both abutment caps.

Earth settlement has exposed the piling. Exposed piling have active corrosion with up to 1/8" section loss during this inspection.

Concrete collars placed adjacent to the abutments in the past as an erosion countermeasure are undermined.

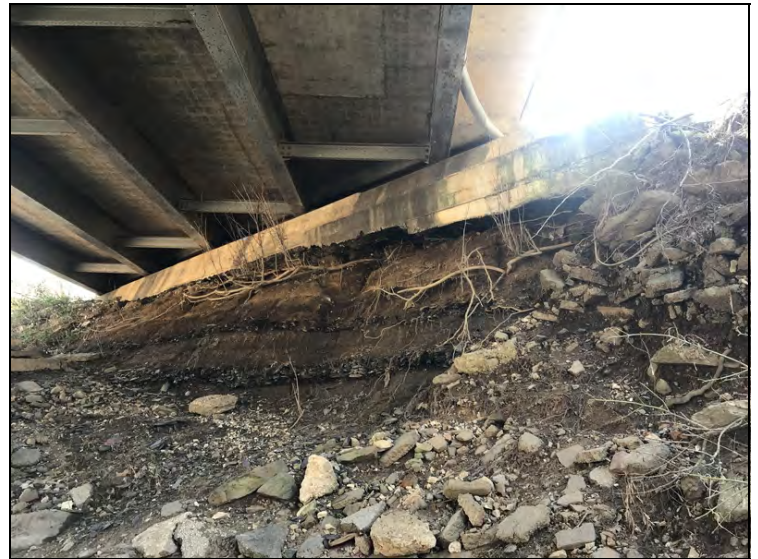
South embankment erosion at abutment 2.

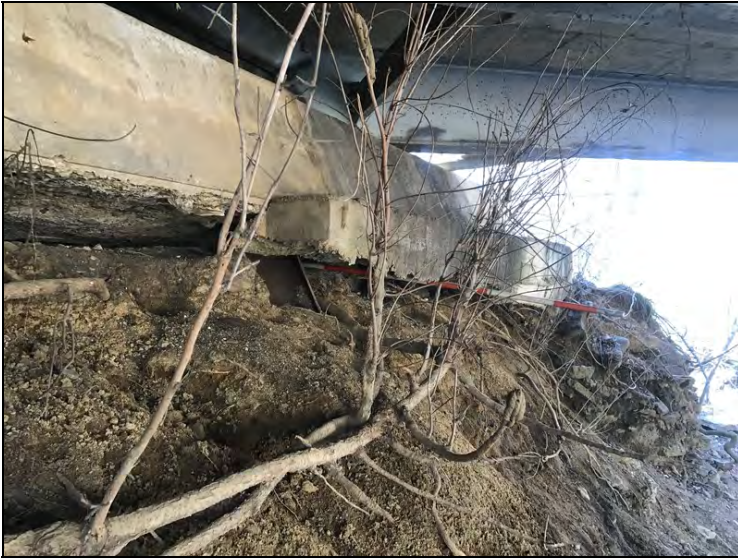
Abutment #2 with full depth erosion under the abutment cap.

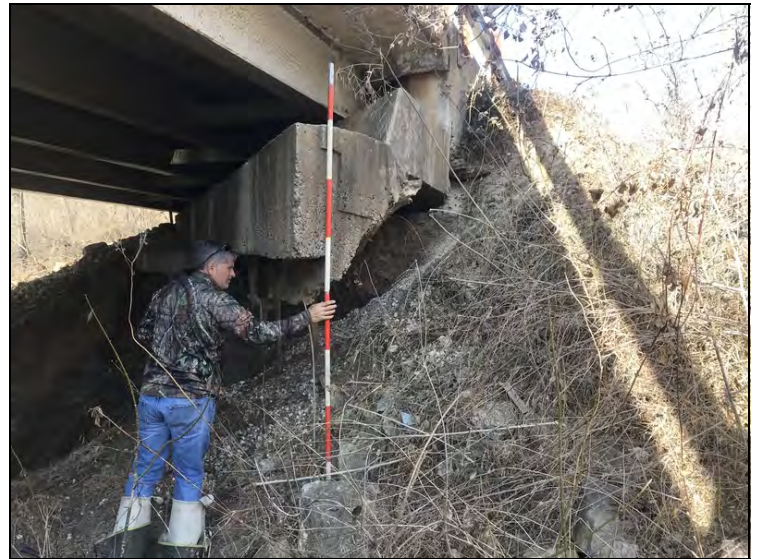
Abutment #1 Lt erosion under the edge of the abutment.

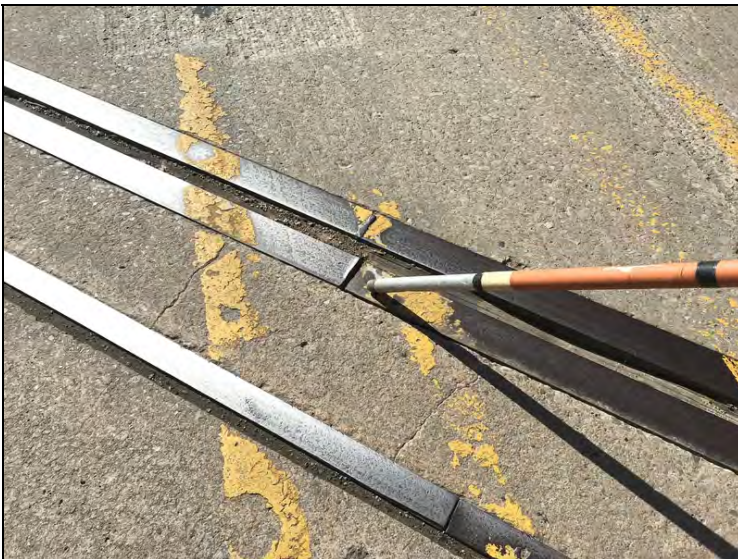
The expansion joint anchorage is loose at both abutments. Both joints are noisy and have movement during live load impacts.

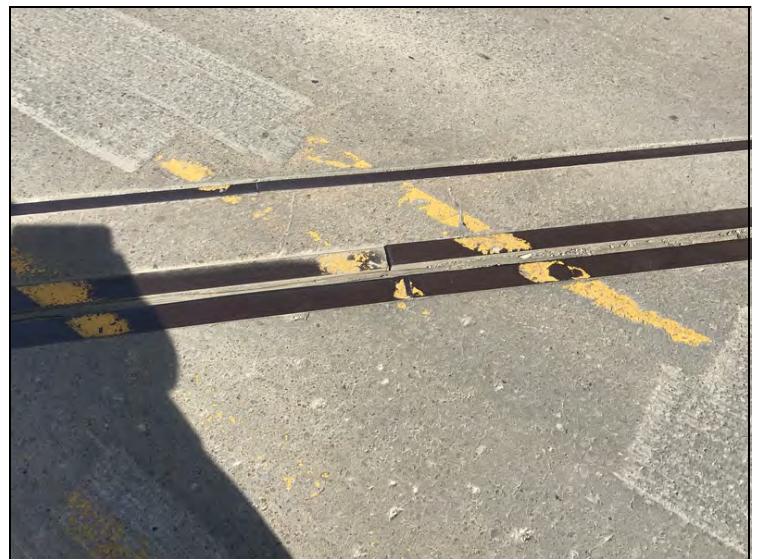
Abutment #1 expansion joint road irons not welded at the centerline.

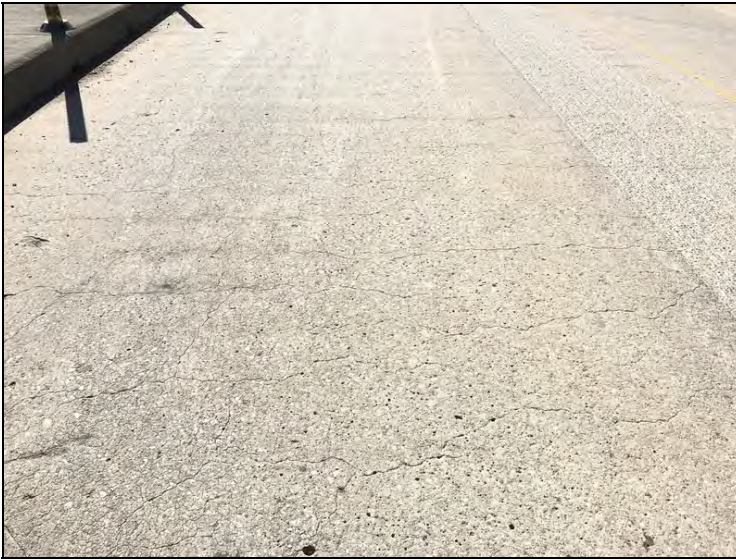
Span 2-Transverse cracking.

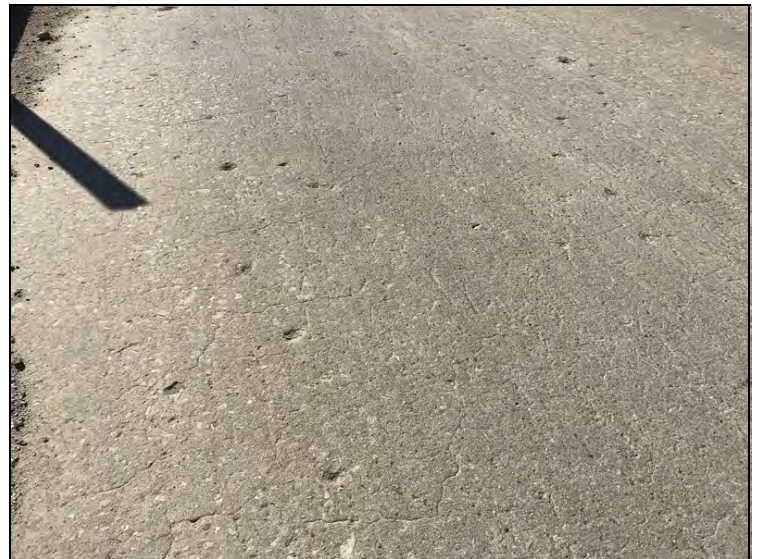
Span 1, left lane-Mapcracking.

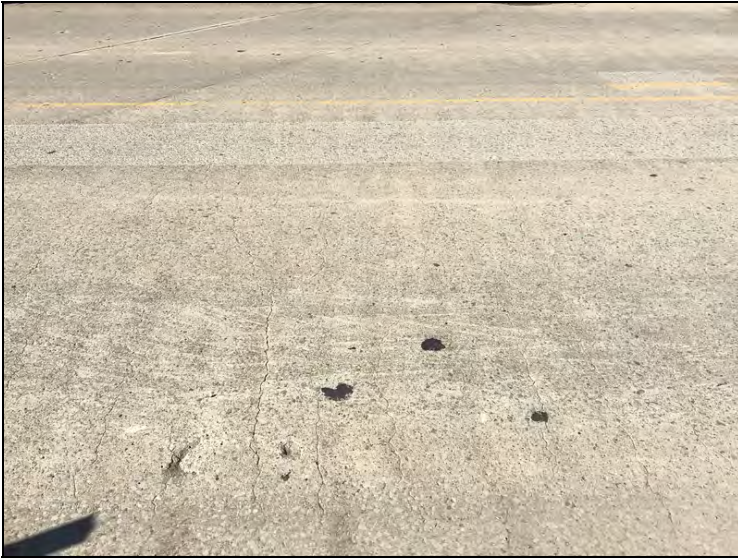
Span 2-Transverse cracking.

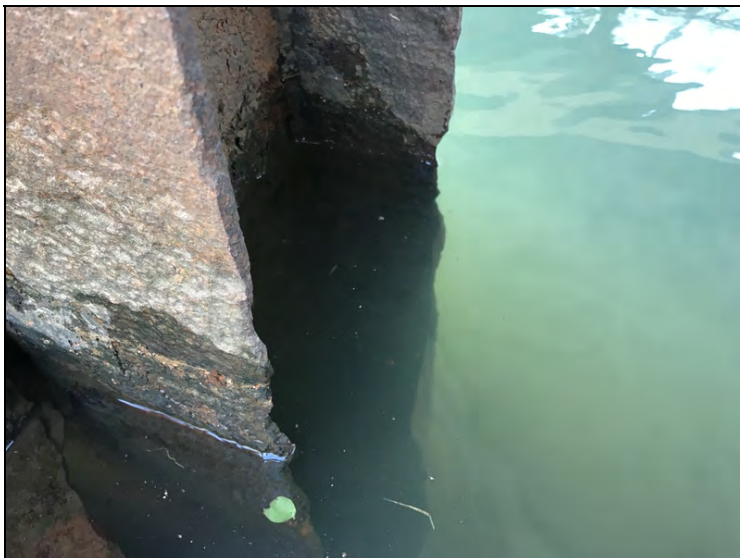
Bent #2, pile #1-Section loss to flange.

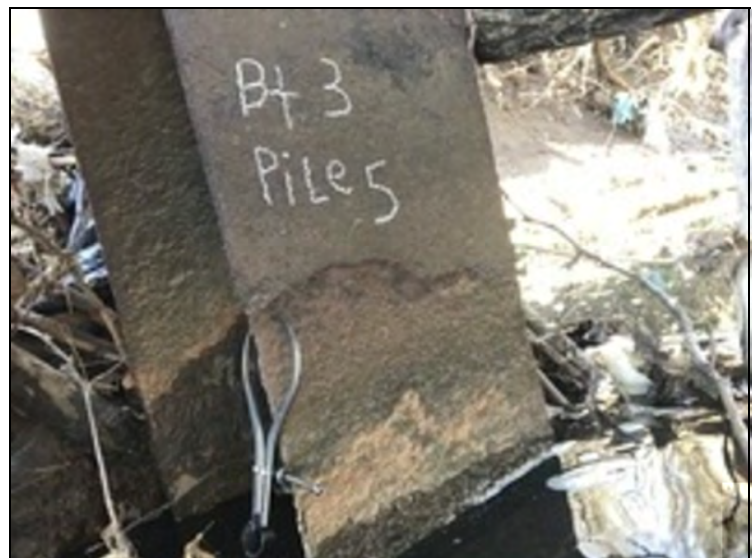
Section loss to pile flange.

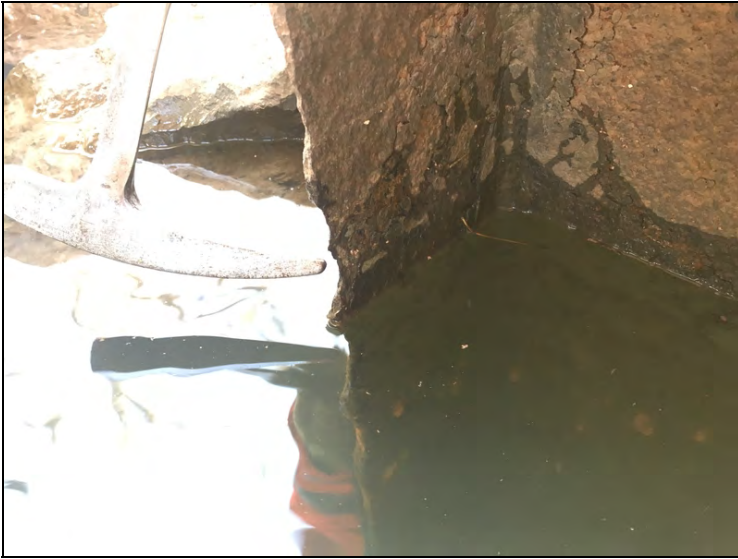
Bent #2, pile 1-Knife edge section loss to flange.

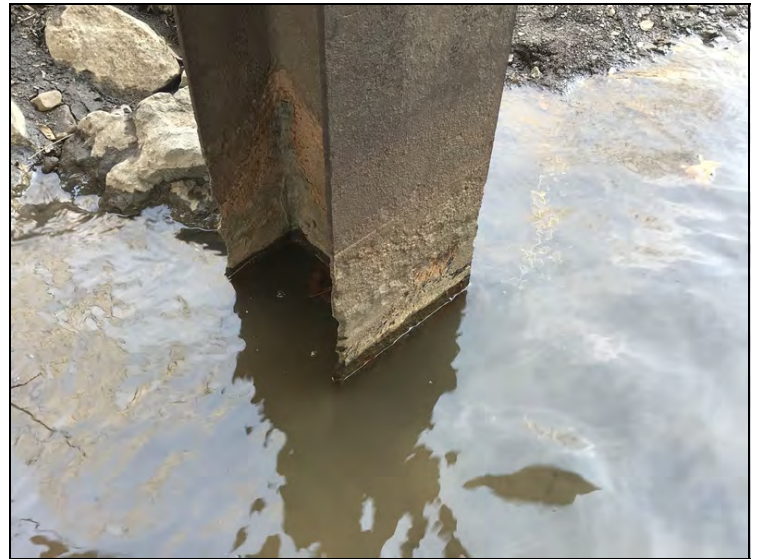
Bent #2 pile #1 with active corrosion and layers of flaking rust with measurable section loss.

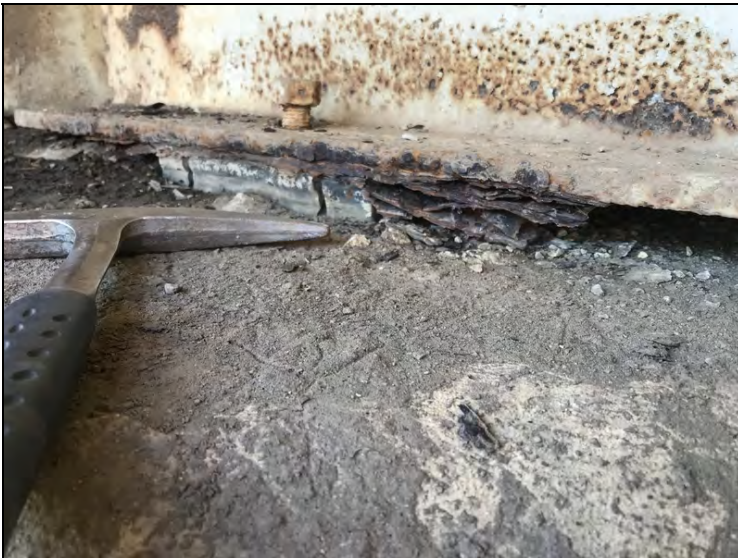
Span 3, beam 1 @ abutment 2-Pack rust 3/16"
section loss.

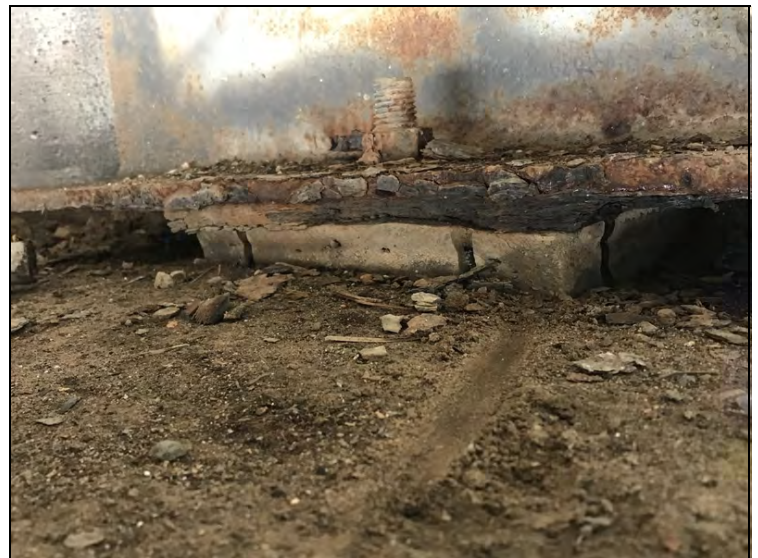
Span 3, beam 3 @ abutment 2-Corrosion.

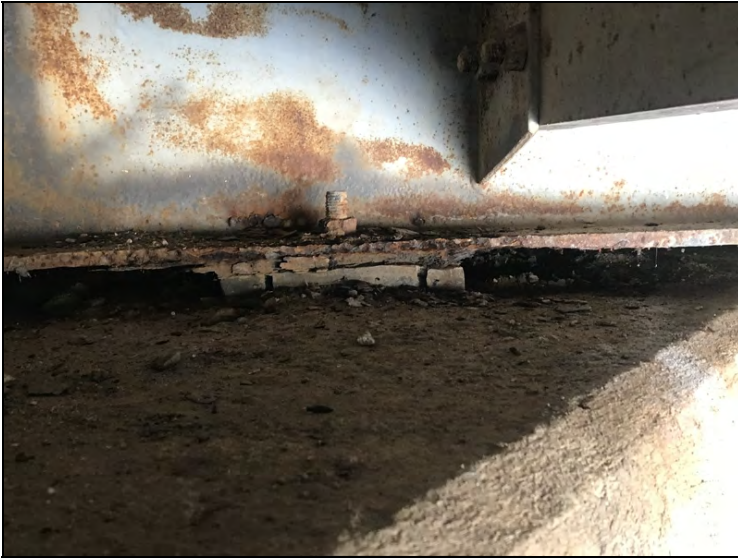
Abutment #2 beam #3 active corrosion with layers of flaking rust and 5/16" remaining section adjacent to the bearing.

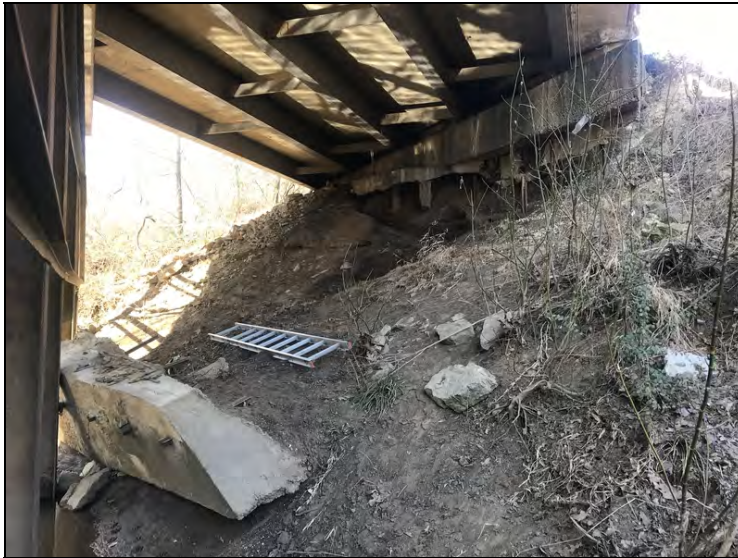
Abutment #1 fractured concrete repair collar.

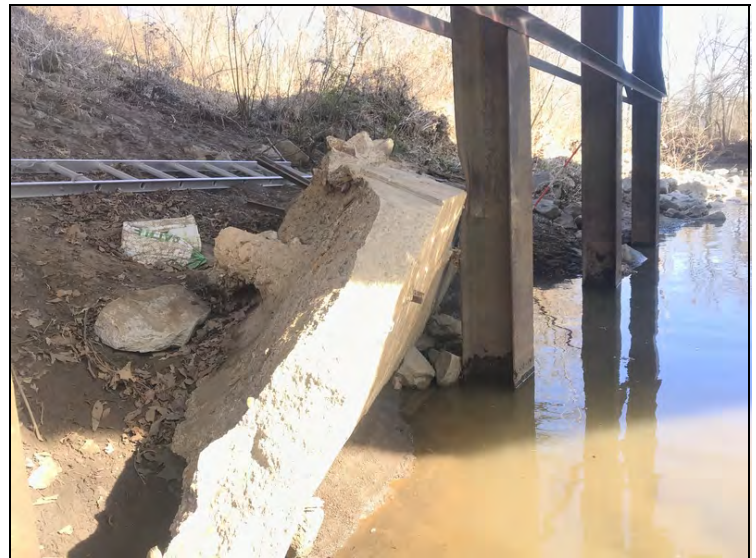
Bent #2 pile #3 out of plane bending.
